December 19, 2020

GEI Project No. 1803049

**Re: Landfill Inspection Report for the
Weston Disposal Site No. 3
Wisconsin Public Service Corporation
Town of Knowlton, Marathon County, Wisconsin**

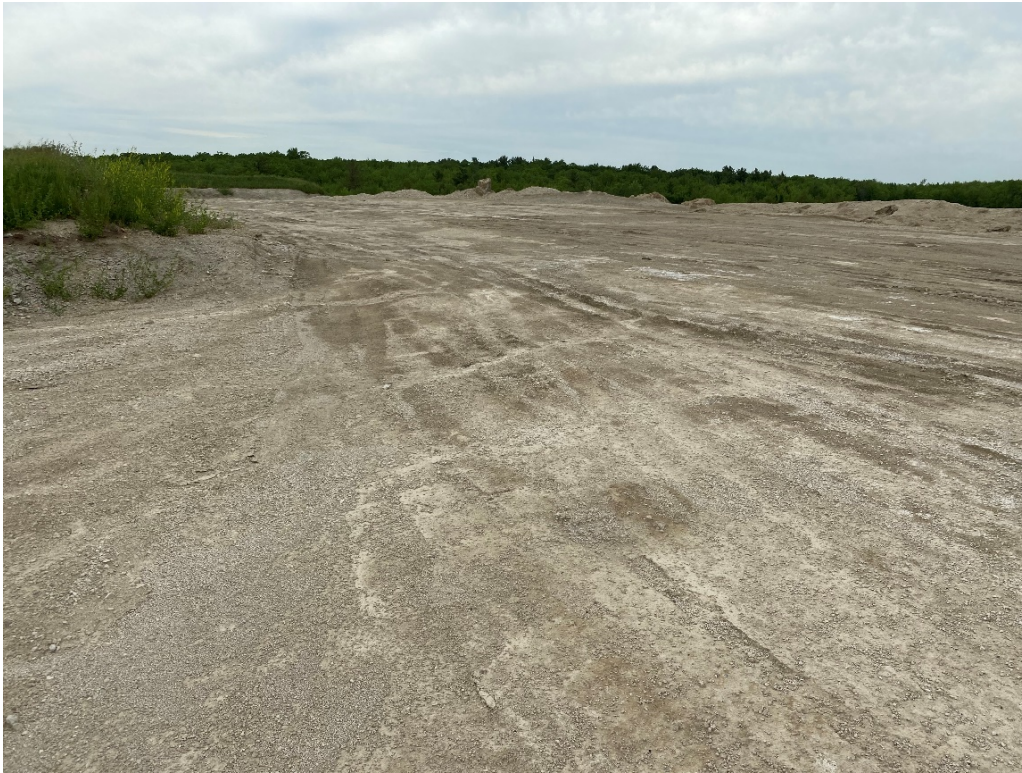
Photo 1 – Looking north showing the active filling area.

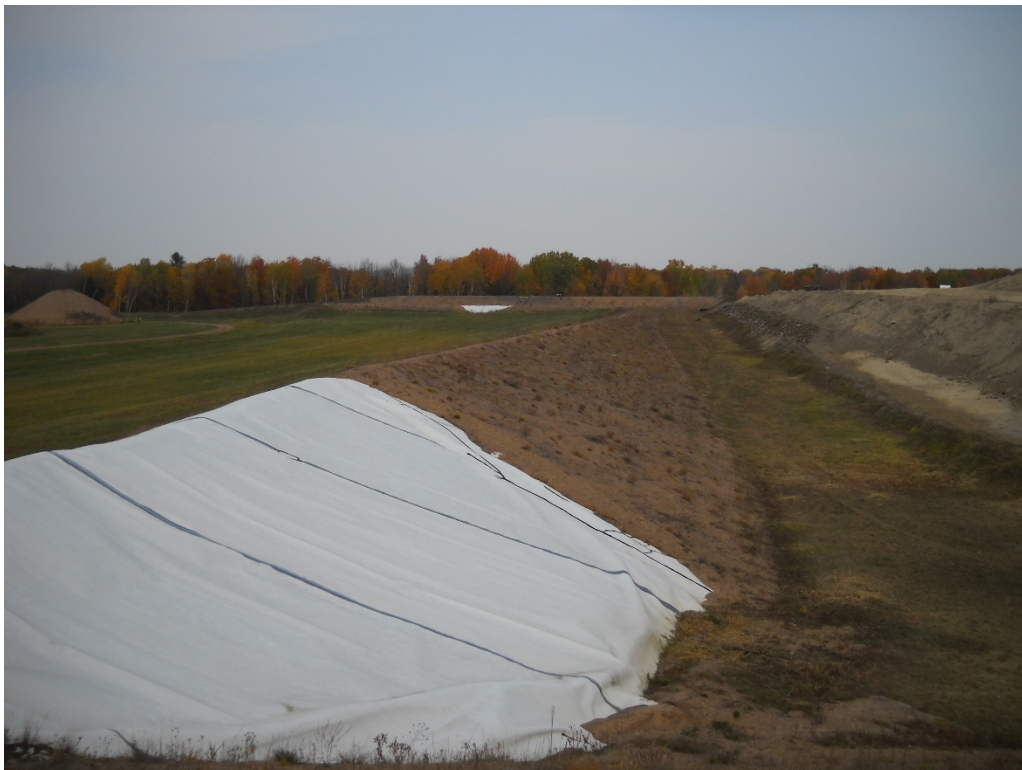
Photo 2 - Along cell 2-3 intercell berm.

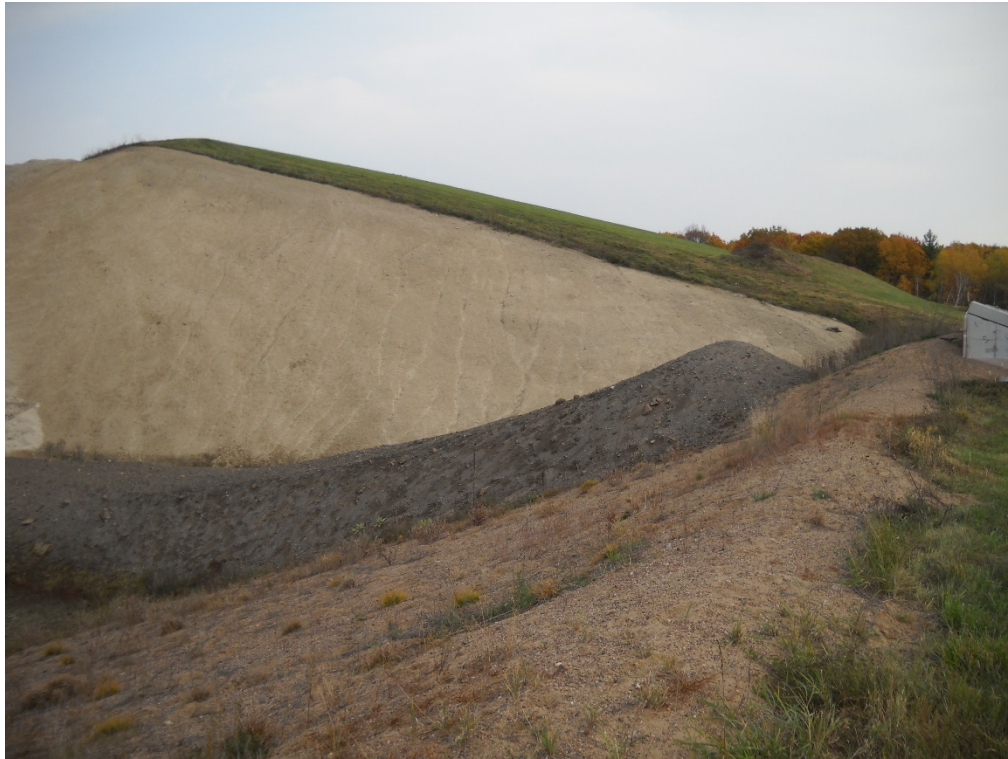
Photo 3 – Along south perimeter berm near Leachate Extraction Vault P2B.

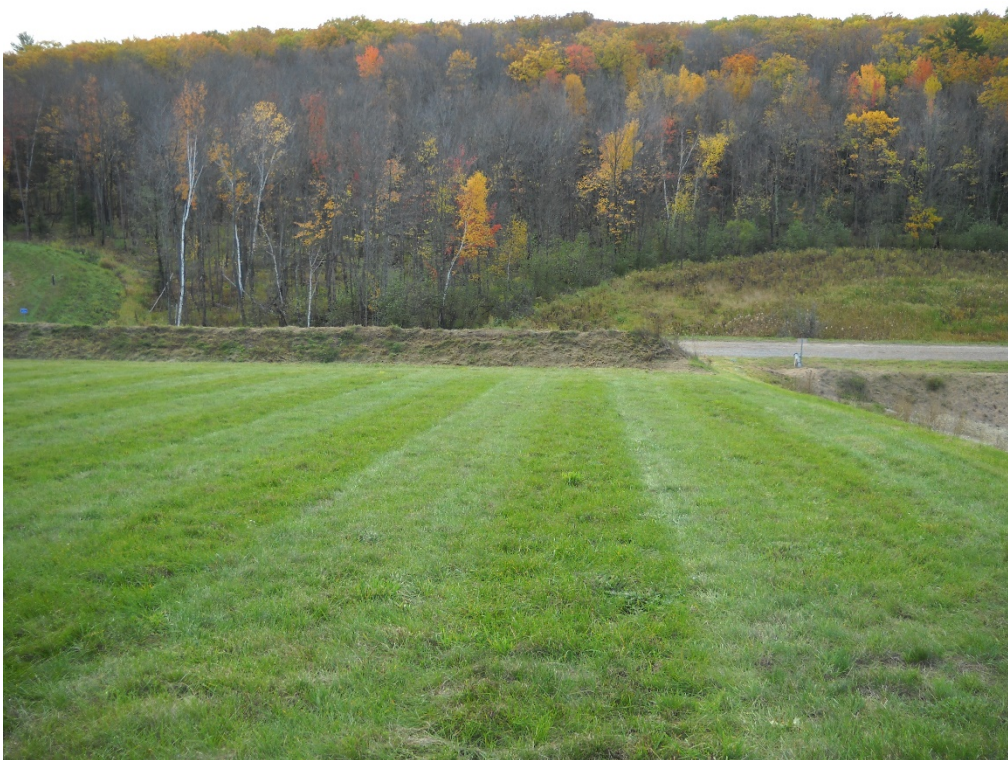
Photo 4 – Looking at the south perimeter slope from the top of the final cover.

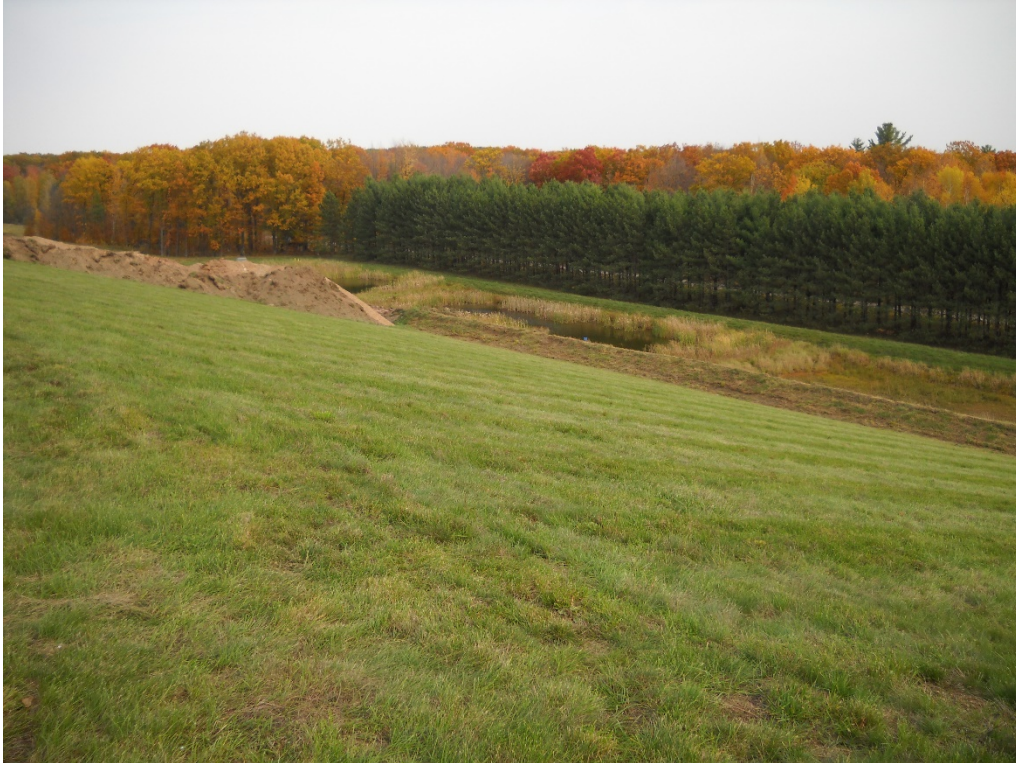
Photo 5 - From top of Cell 2 partial final cover at Stormwater Basin 2 and Stormwater Basin 3.

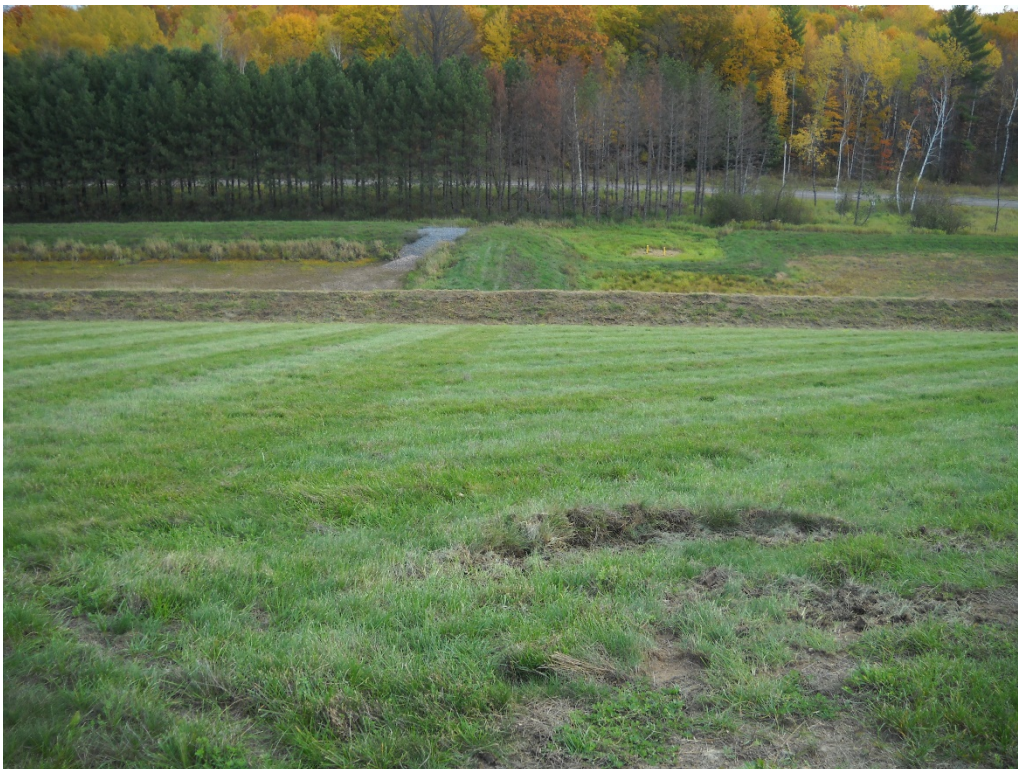
Photo 6 - From top of Cell 2 partial final cover at Stormwater Basin 2.

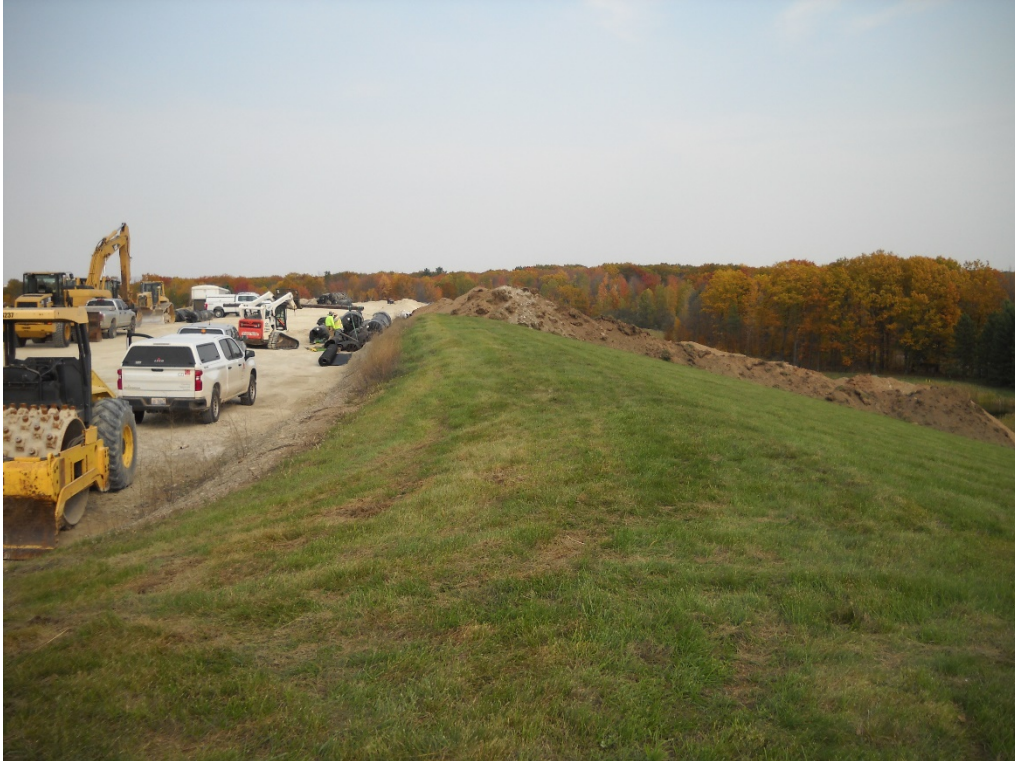
Photo 7 - Along top of Cell 2 partial final cover. Final cover activities ongoing.

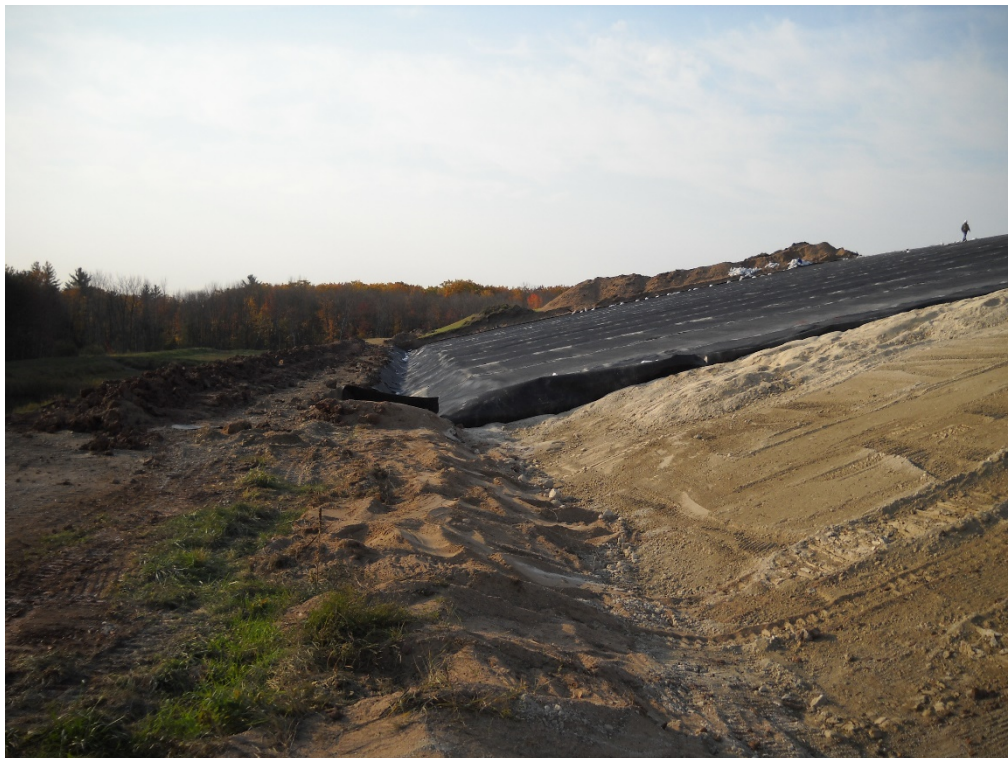
Photo 8 – Looking south to final cover and active filling area.

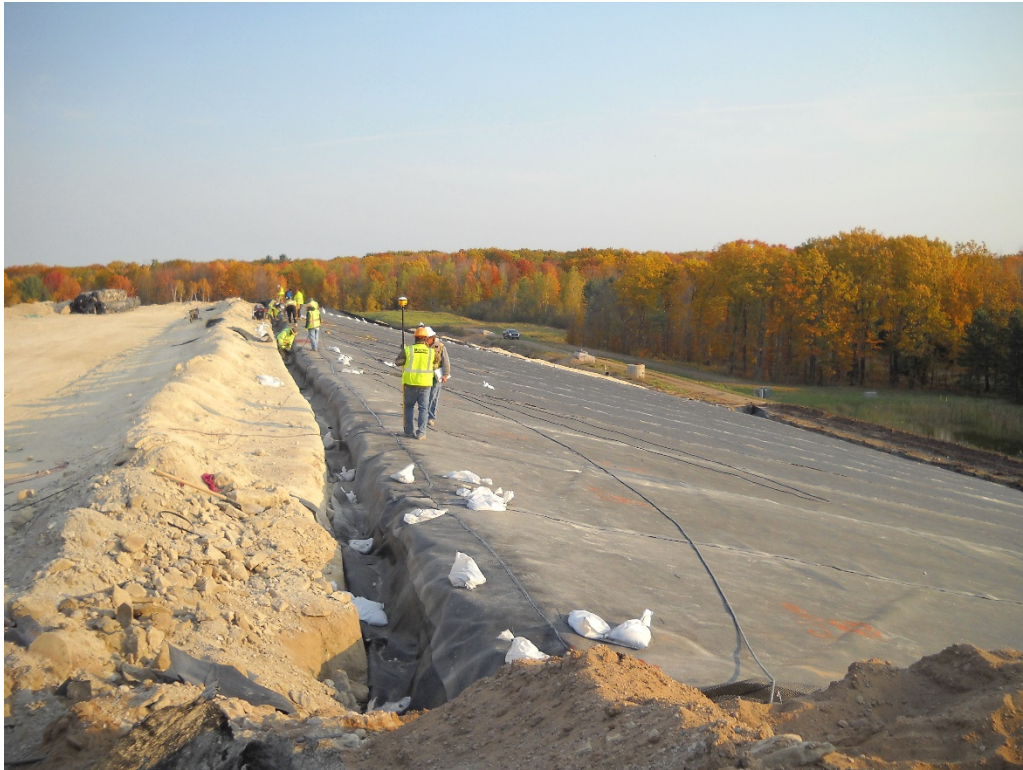
Photo 9 - Looking at covered east slope in Cell 2 towards Cell 1.

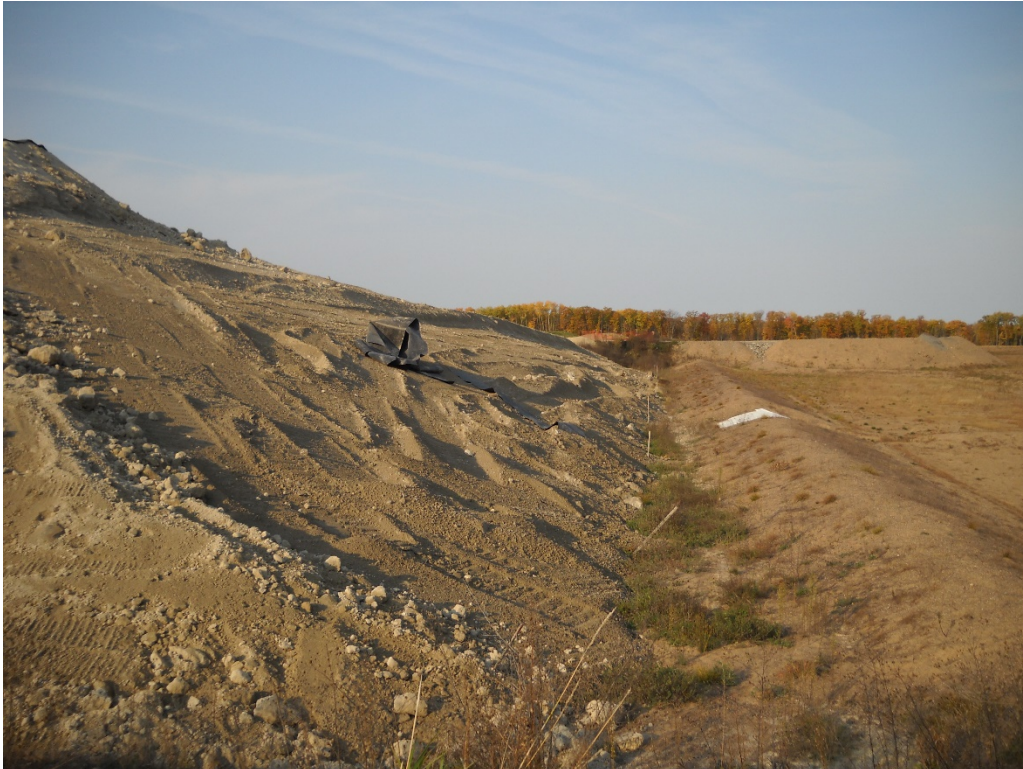
Photo 10 - Looking at north ash slope in Cell 2.

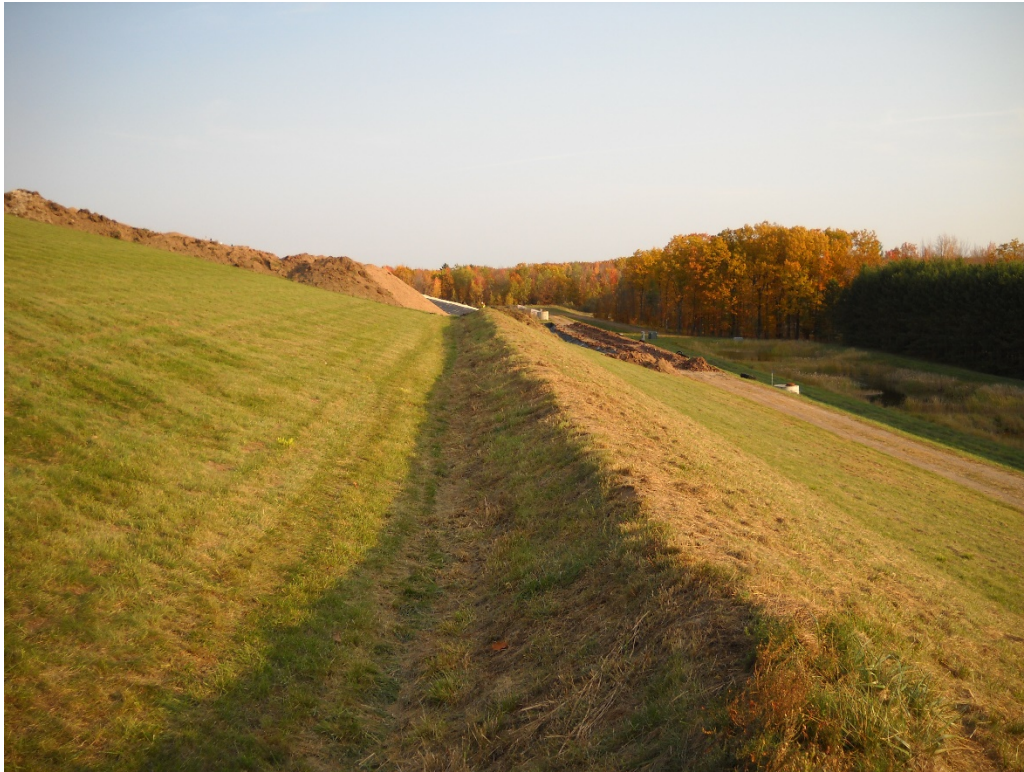
Photo 11 - Looking north to the west showing stormwater control ditch.

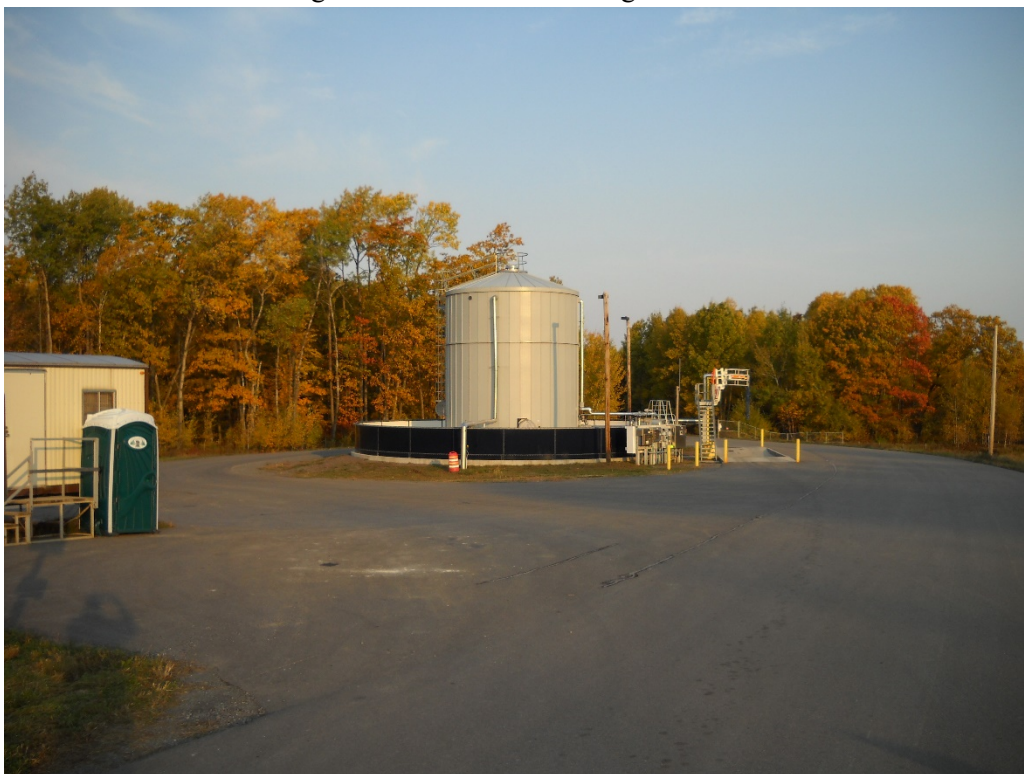
Photo 12 – Leachate collection tank and loadout facility.

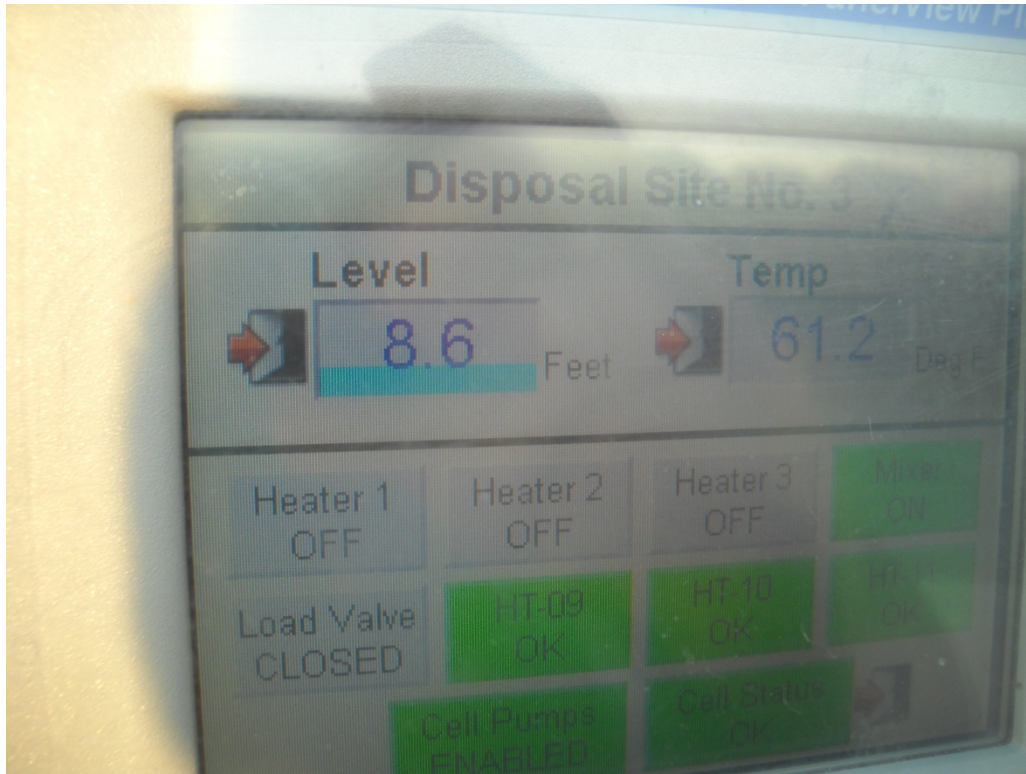
Photo 13 – Leachate collection tank readout showing 8.6 feet of leachate.
