December 10, 2021  
Project 2103691

**Re: Landfill Inspection Report for the  
Weston Disposal Site No. 3  
Wisconsin Public Service Corporation  
Town of Knowlton, Marathon County, Wisconsin**

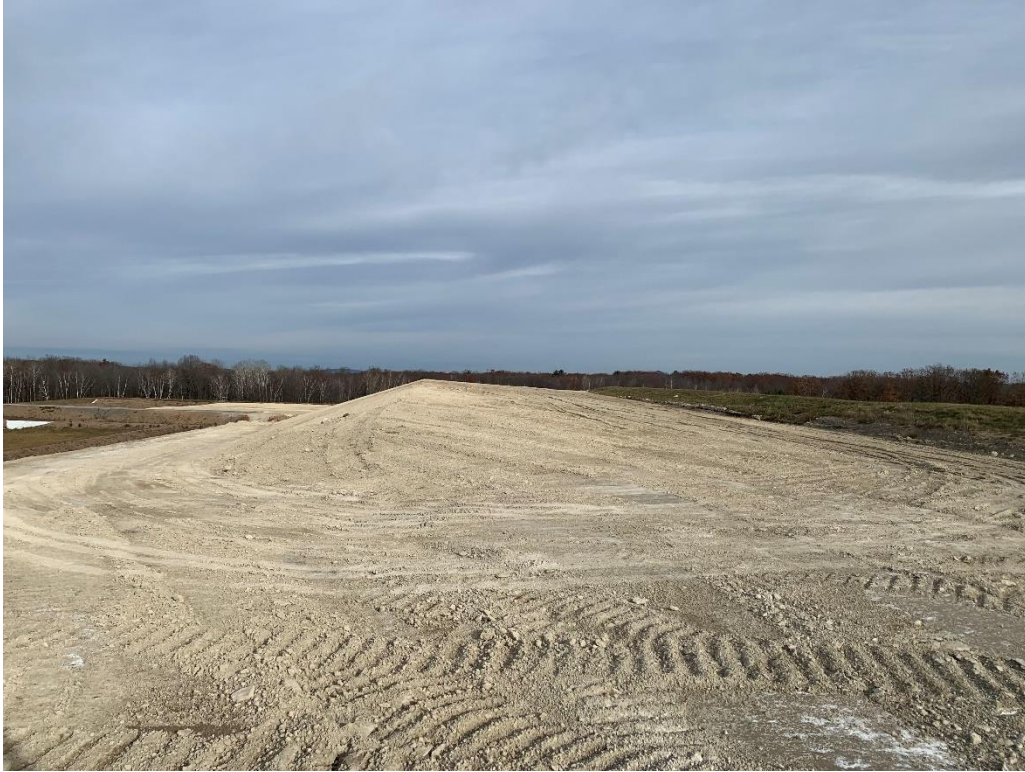
Photo 1 – Looking north showing the Cell 2 active filling area.

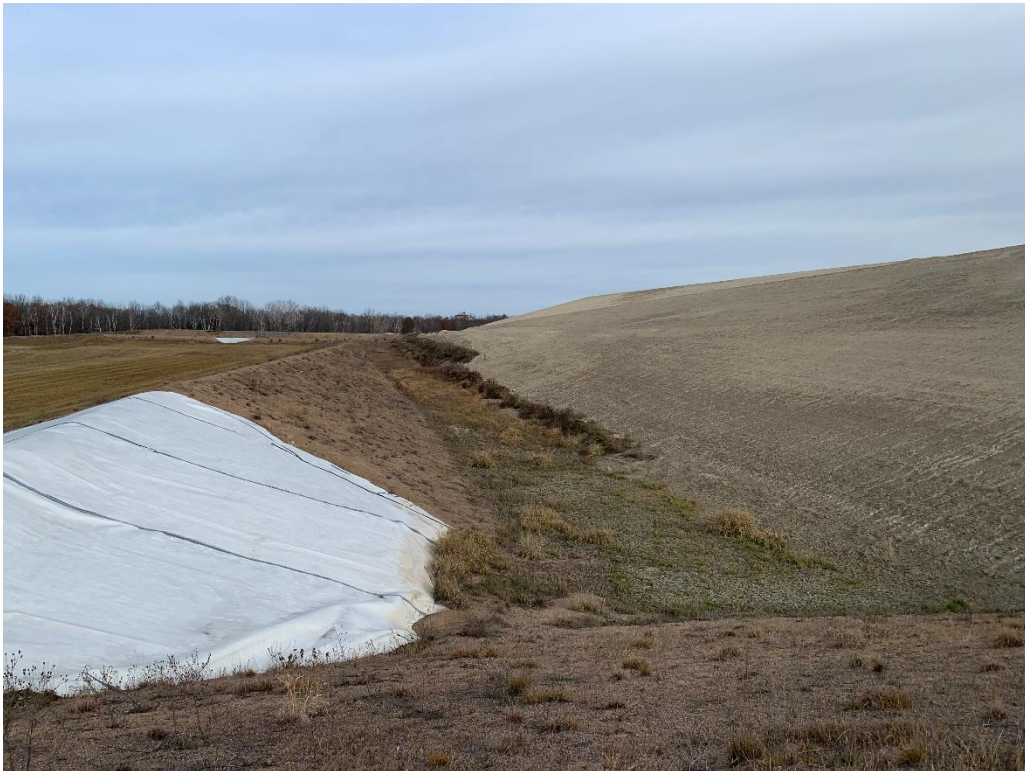
Photo 2 - Along Cell 2-3 intercell berm.

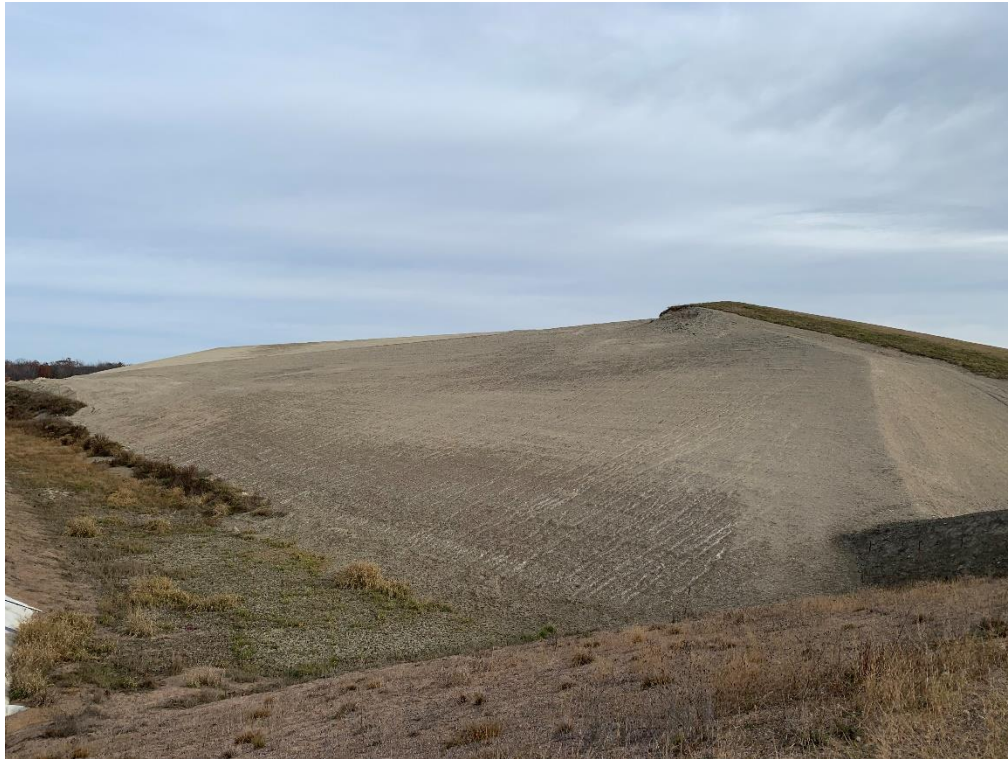
Photo 3 – Along south perimeter berm near Leachate Extraction Vault P2B.

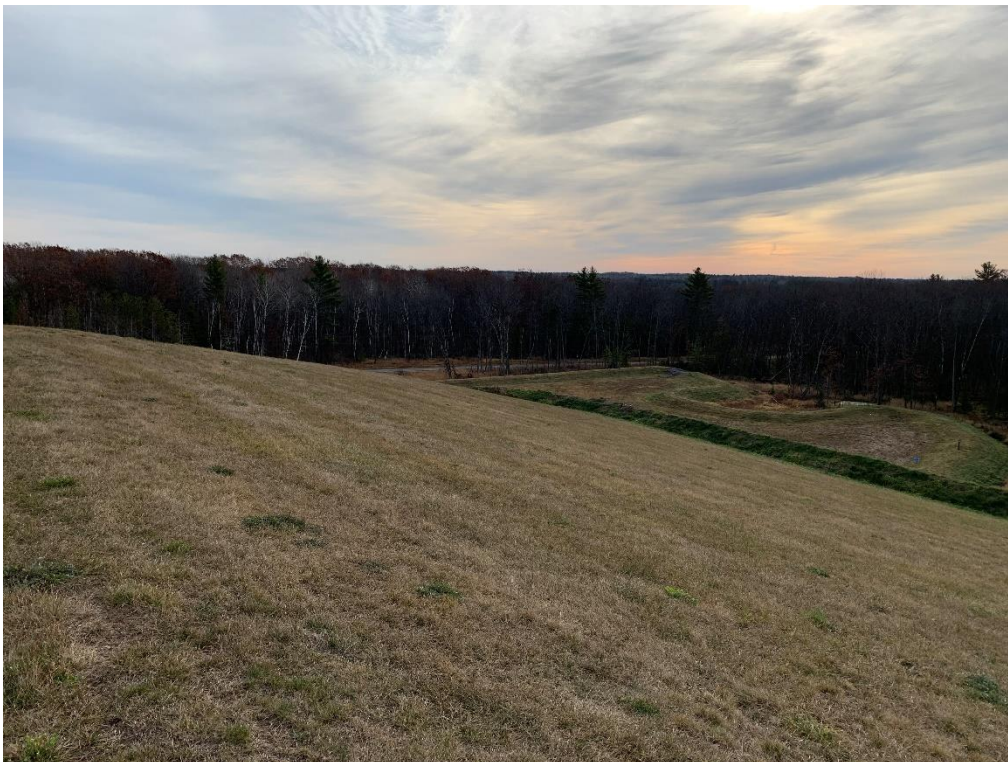
(iii) The perimeter slopes of Cells 1 and 2, and the final cover slopes of Cell 2 appear to be in excellent condition with no signs of instability, structural weakness, significant erosion, woody vegetation, or animal burrows.

Photo 4 – Looking at the south perimeter slope from the top of the final cover.

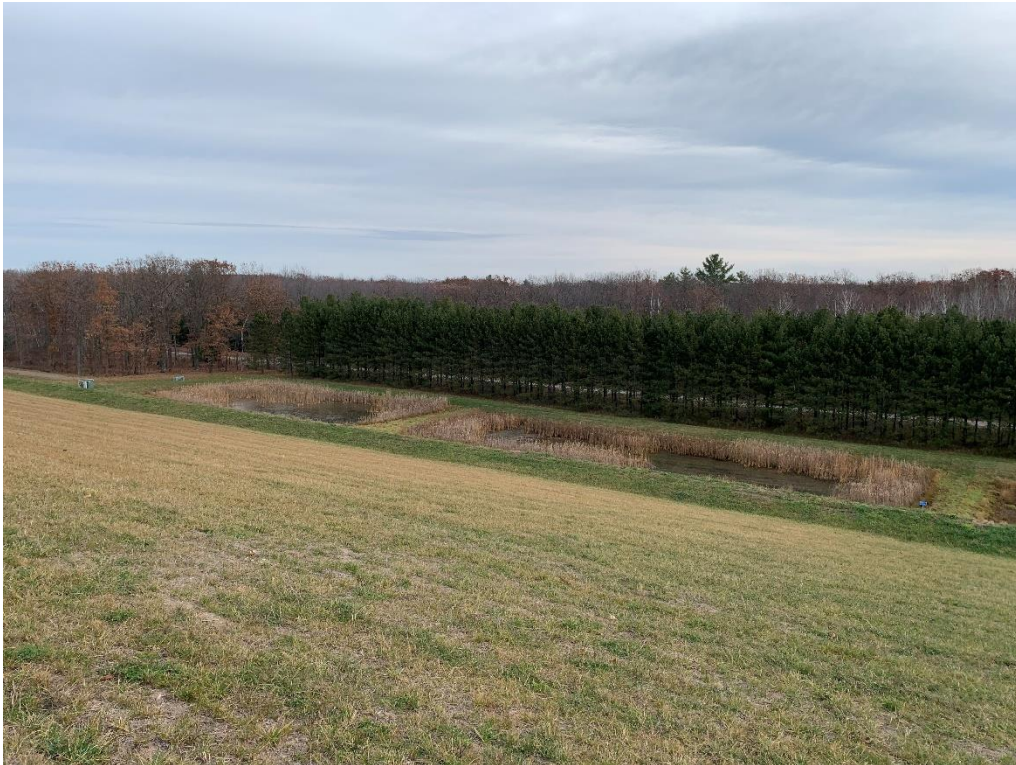
Photo 5 - From top of Cell 2 partial final cover at Stormwater Basin 2 and Stormwater Basin 3.

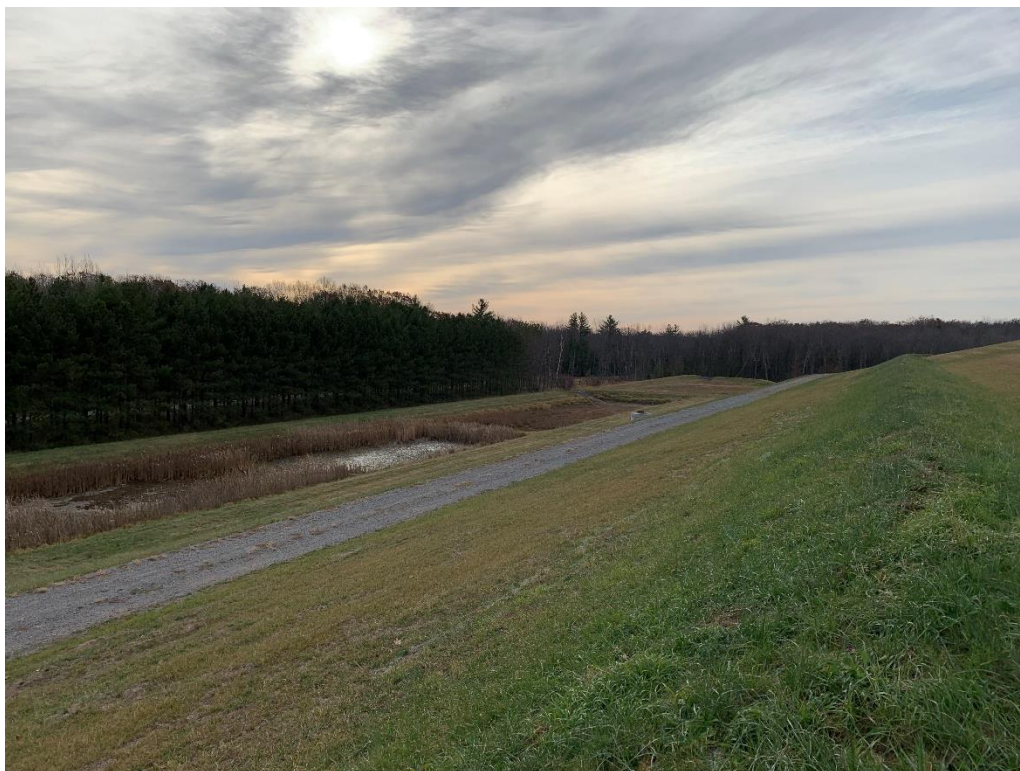
Photo 6 - From top of Cell 2 partial final cover at Stormwater Basin 2.

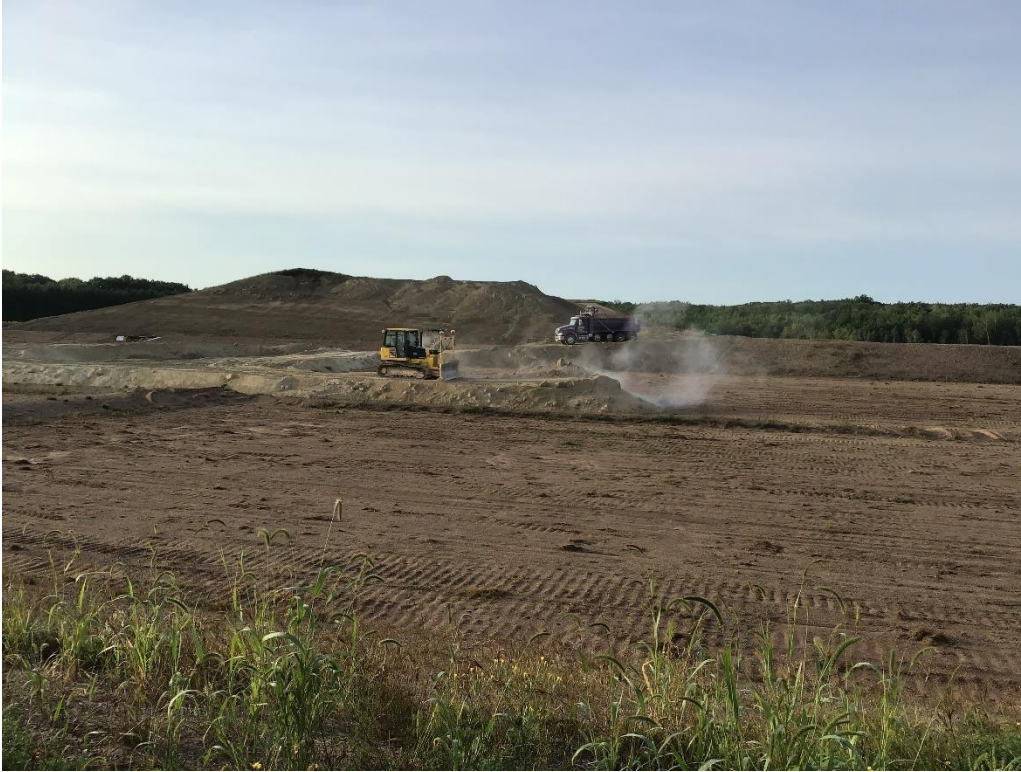
Photo 7 – Placing and spreading the frost protection layer in August. Vegetation was stripped before placement.

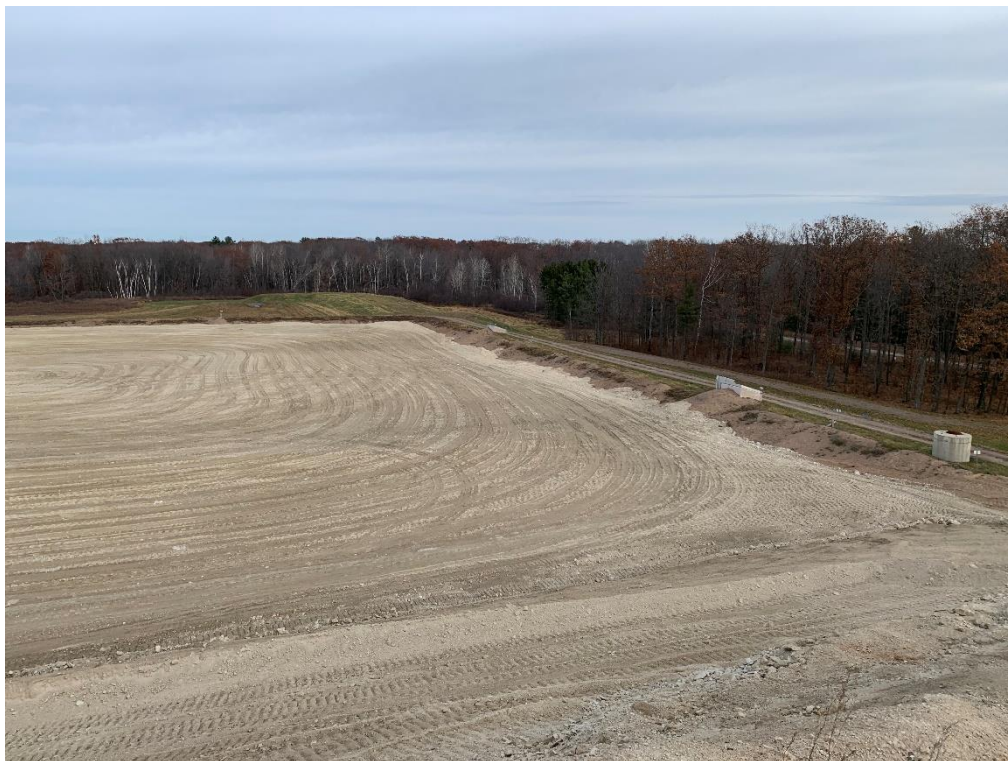
Photo 8 – Looking north to the Cell 1 active filling area showing frost protection layer.

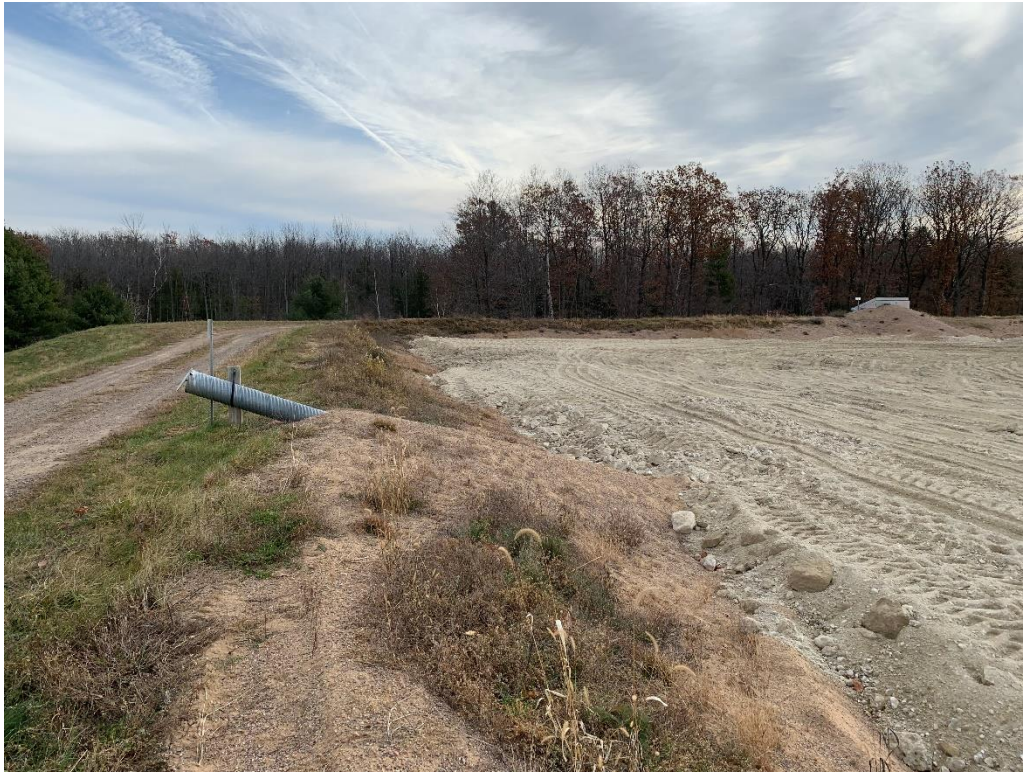
Photo 9 - Looking east at Cell 1 perimeter slopes showing the frost protection layer.

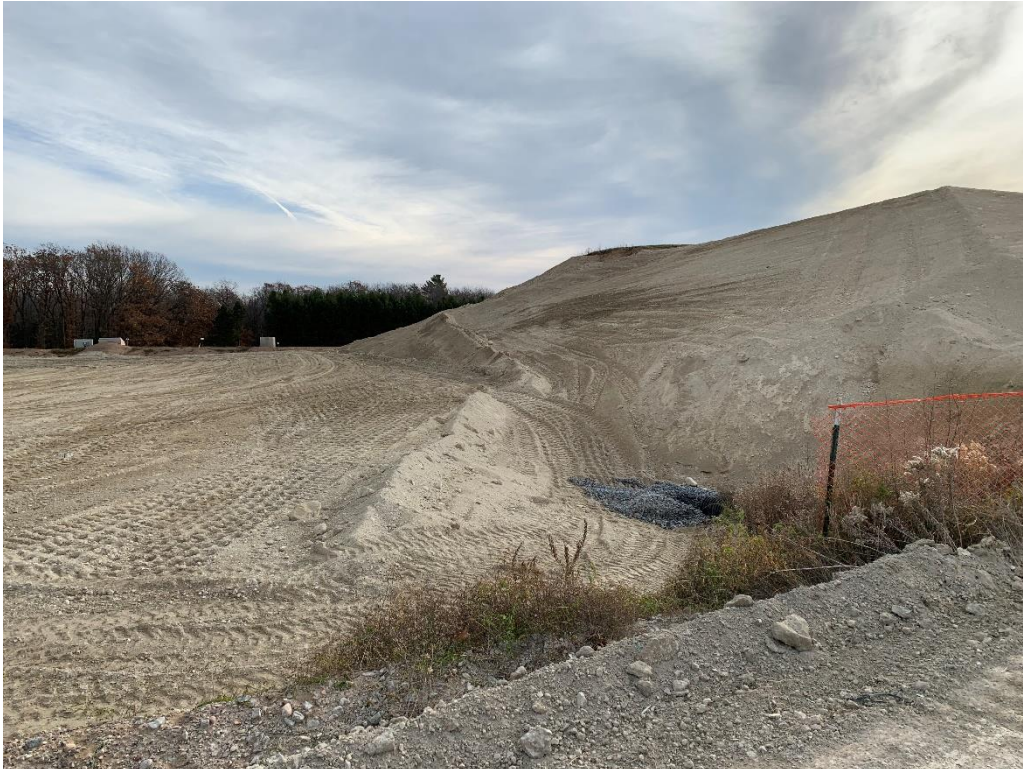
Photo 10 - Looking at north ash slope in Cell 2 and frost protection layer in Cell 1.

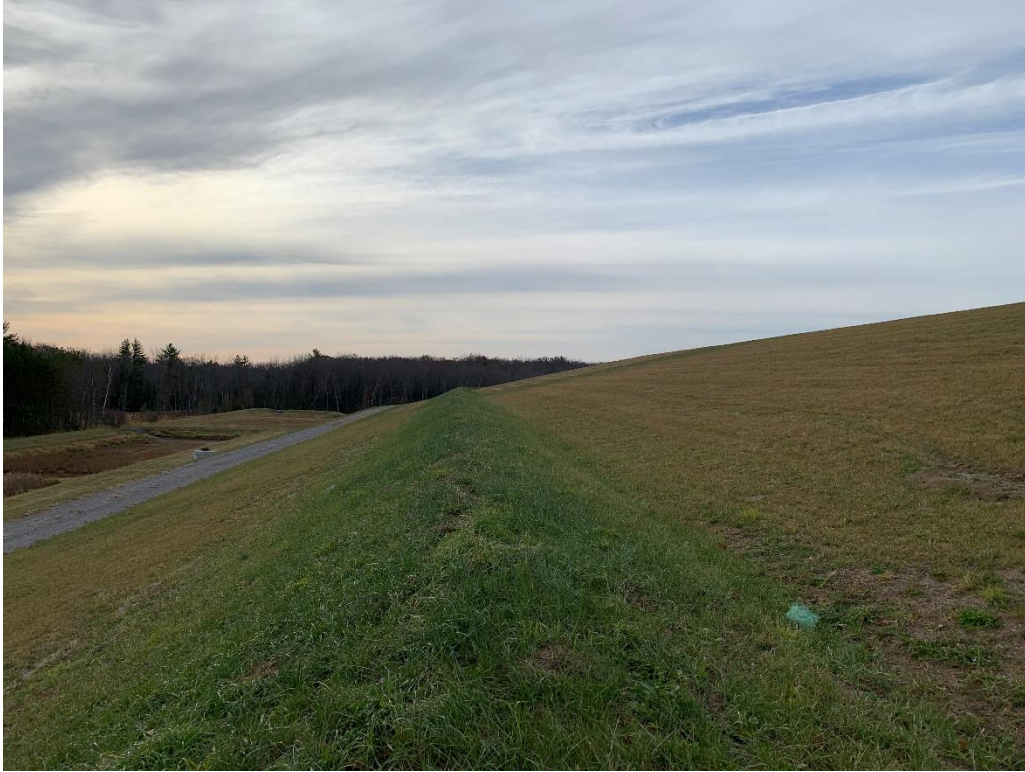
Photo 11 - Looking south at the east stormwater control ditch.

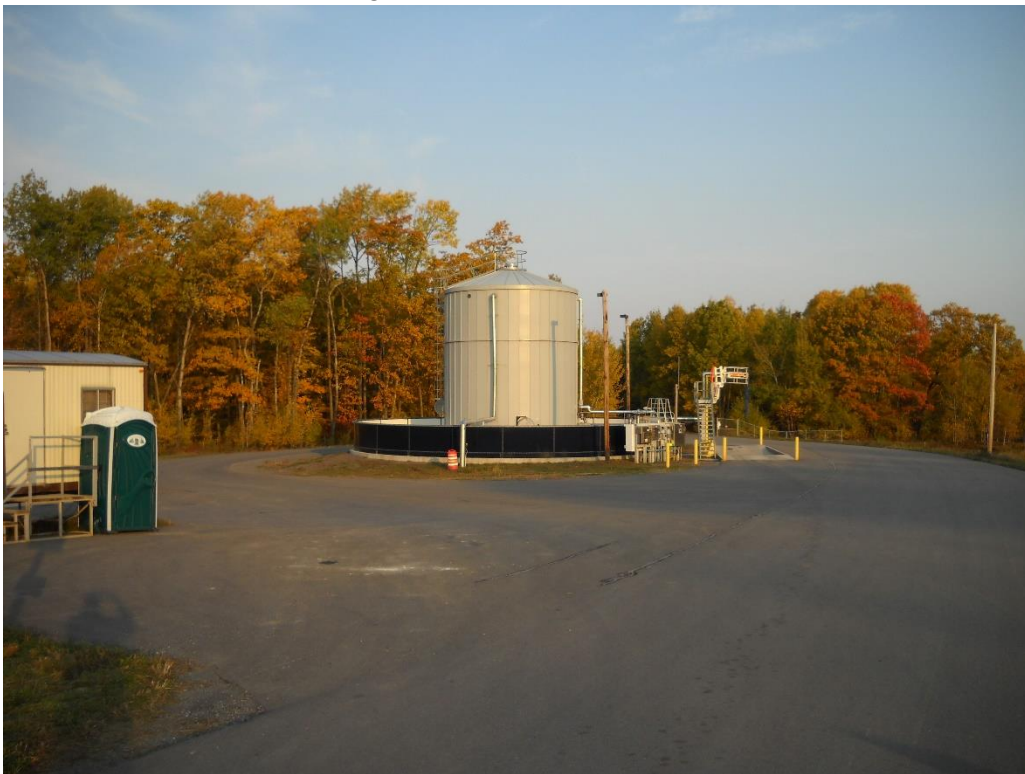
Photo 12 – Leachate collection tank and loadout facility.
