December 19, 2023  
Project 2103691

**Re: 2023 Landfill Inspection Report  
Weston Disposal Site No. 3  
Wisconsin Public Service Corporation  
Town of Knowlton, Marathon County, Wisconsin**

# Weston Disposal Site No. 3 Landfill CCR Inspection – Photo Log

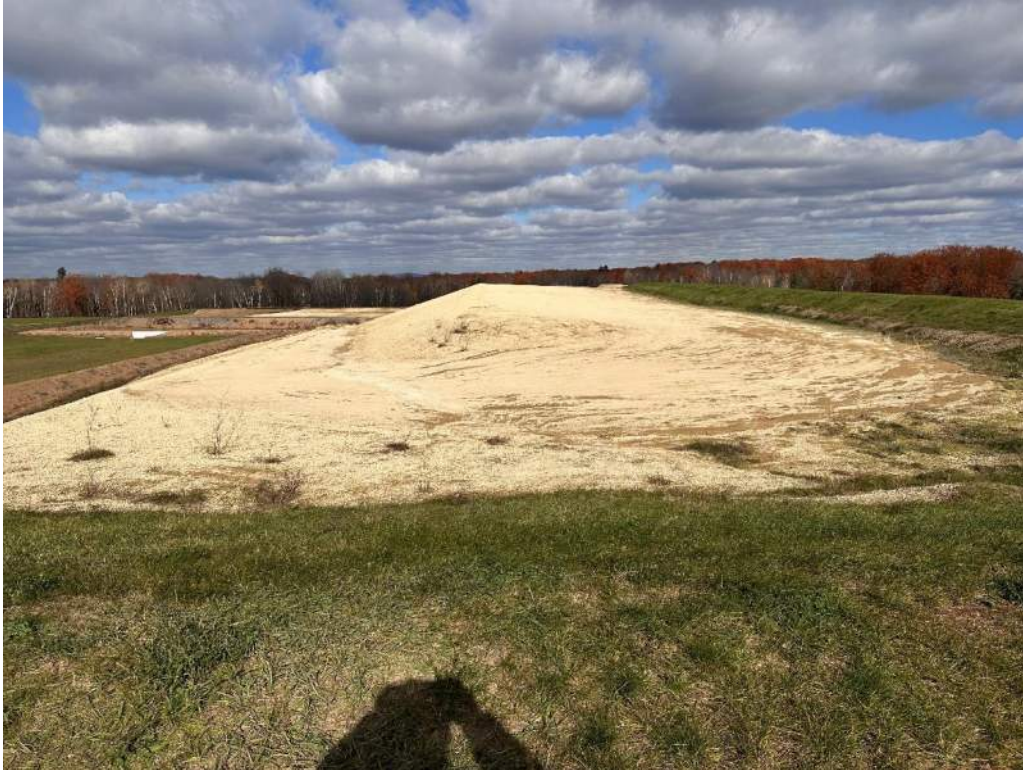
Photo No. 1 – Active filling area on Cell 2, looking north.

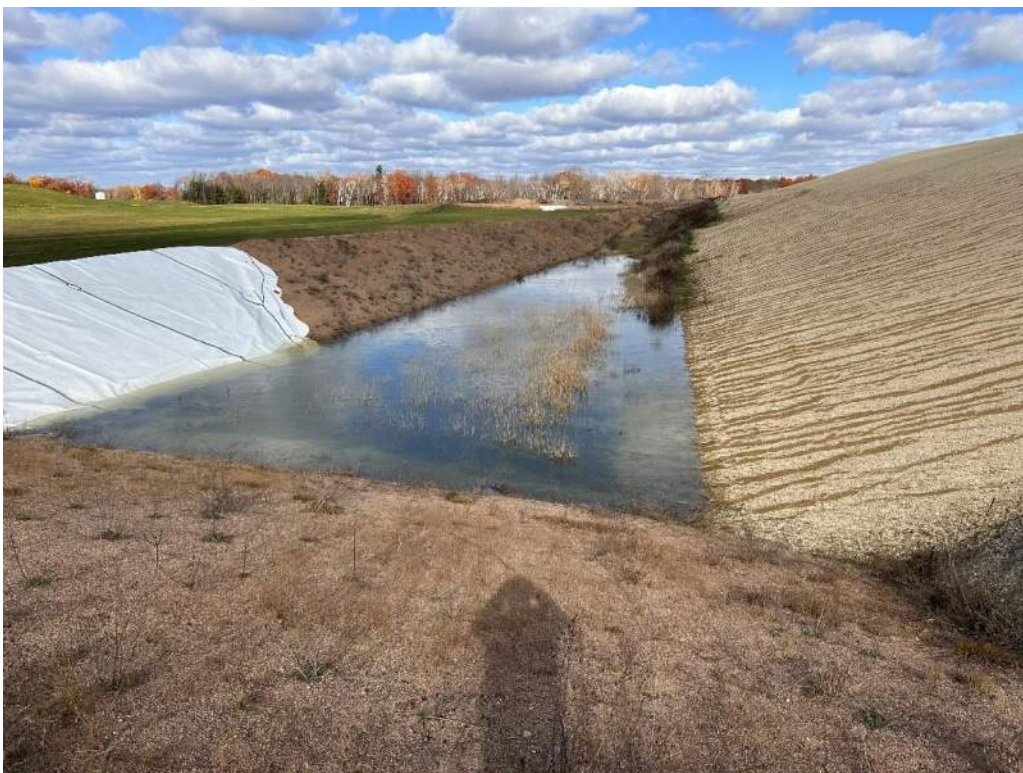
Photo No. 2 – Cell 2/3 intercell berm and leachate collection ditch along west side of Cell 2.

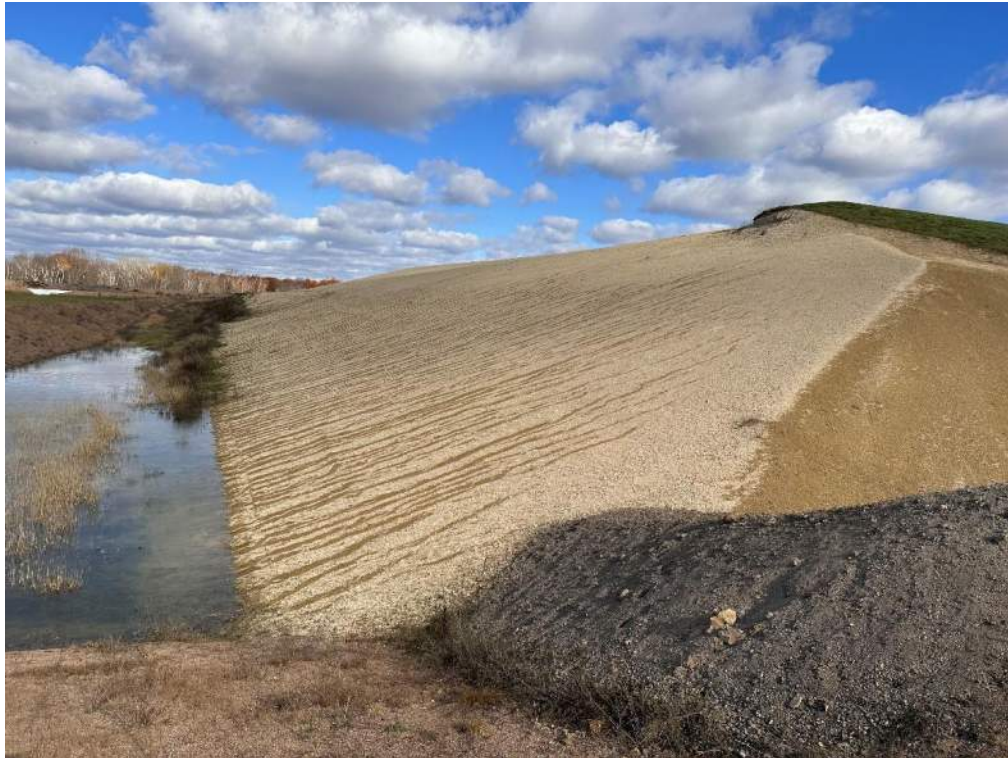
Photo No. 3 – Cell 2 west slope.

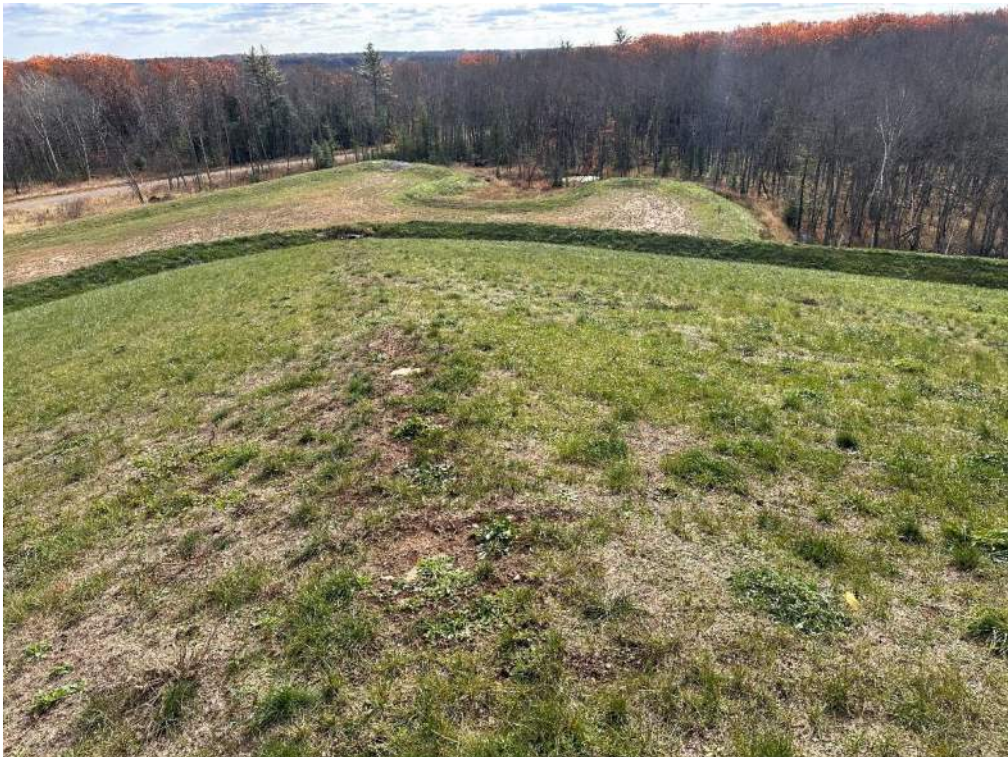
Photo No. 4 – Cell 2 south and east slope and stormwater diversion berm.

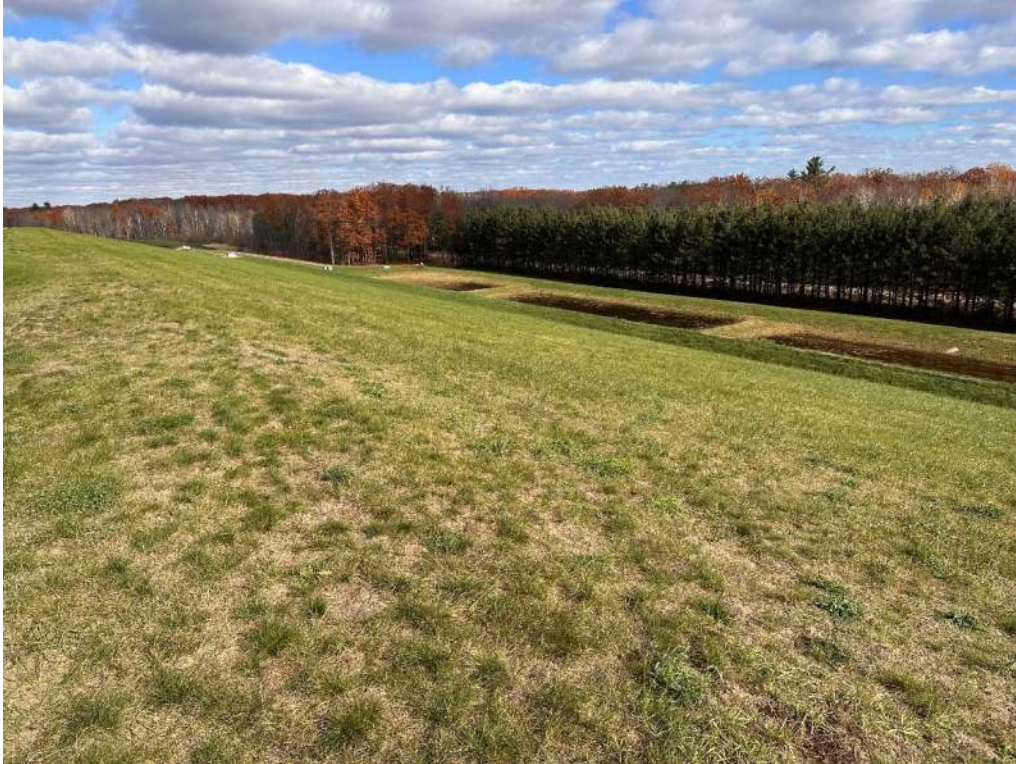
Photo No. 5 – Stormwater Basin 2 east of Cell 2.

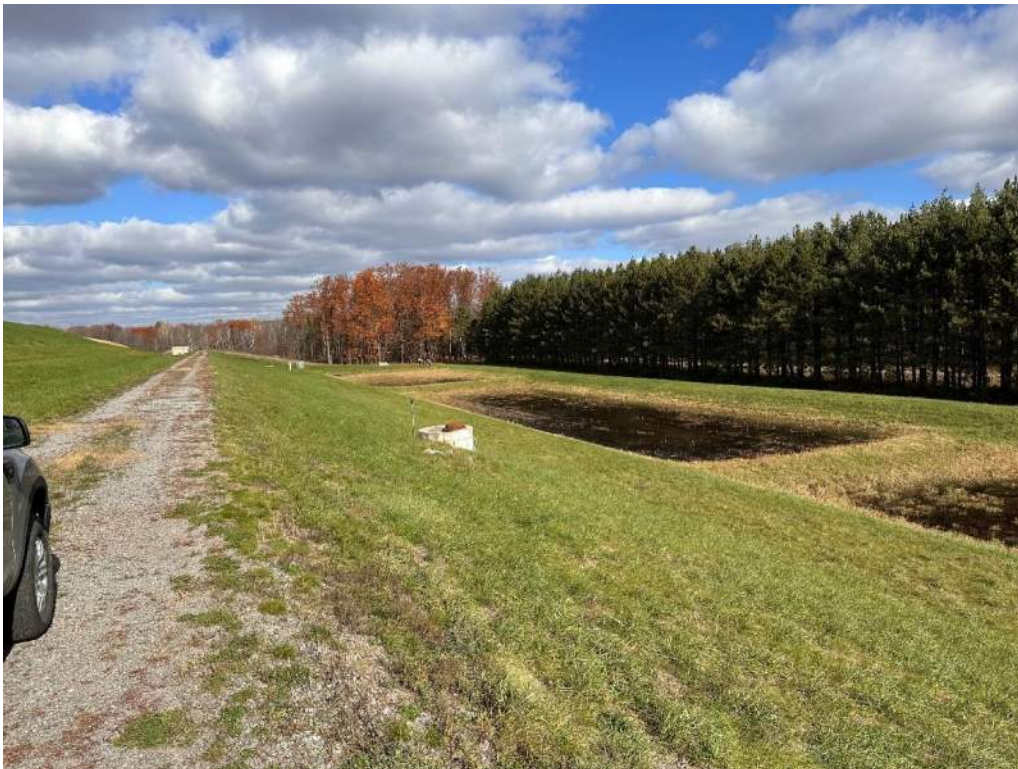
Photo No. 6 – Stormwater Basin 2.

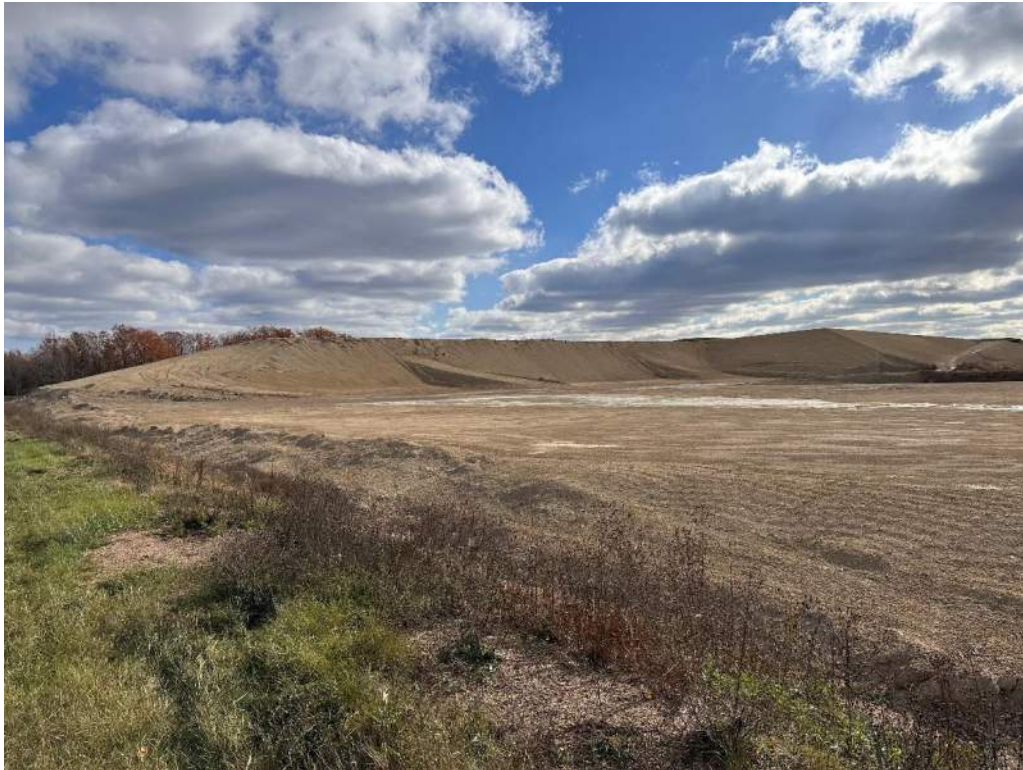
Photo No. 7 – Active filling area in Cell 1, looking east.

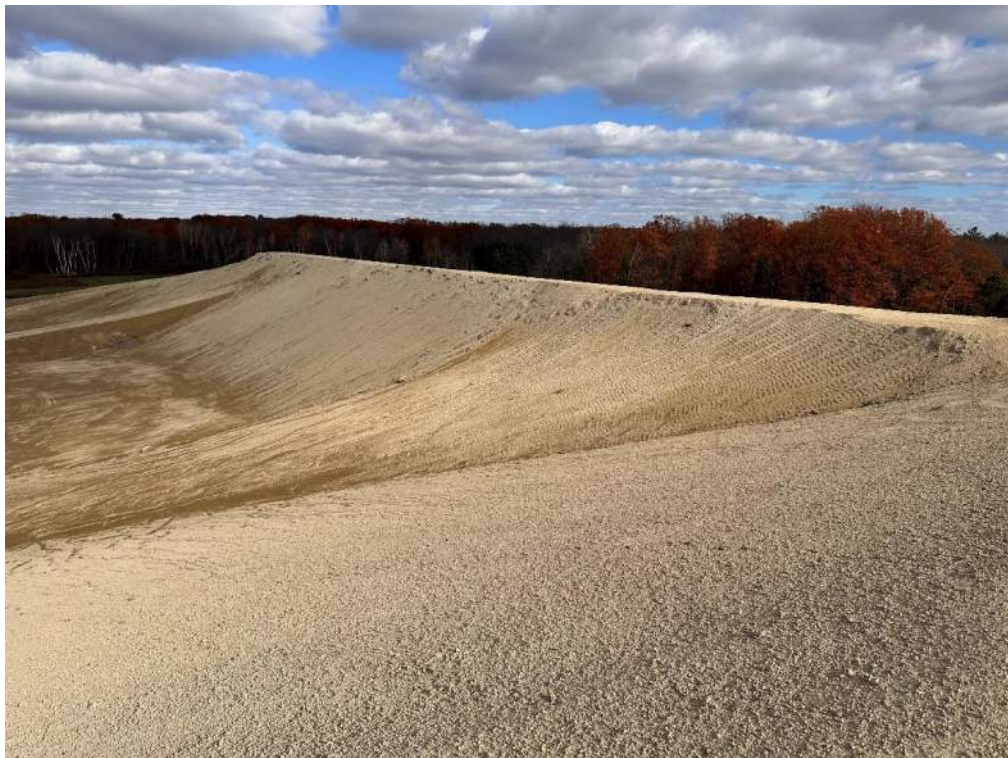
Photo No. 8 – Looking northeast to the Cell 1 active filling area and the east slope prepared for final cover.

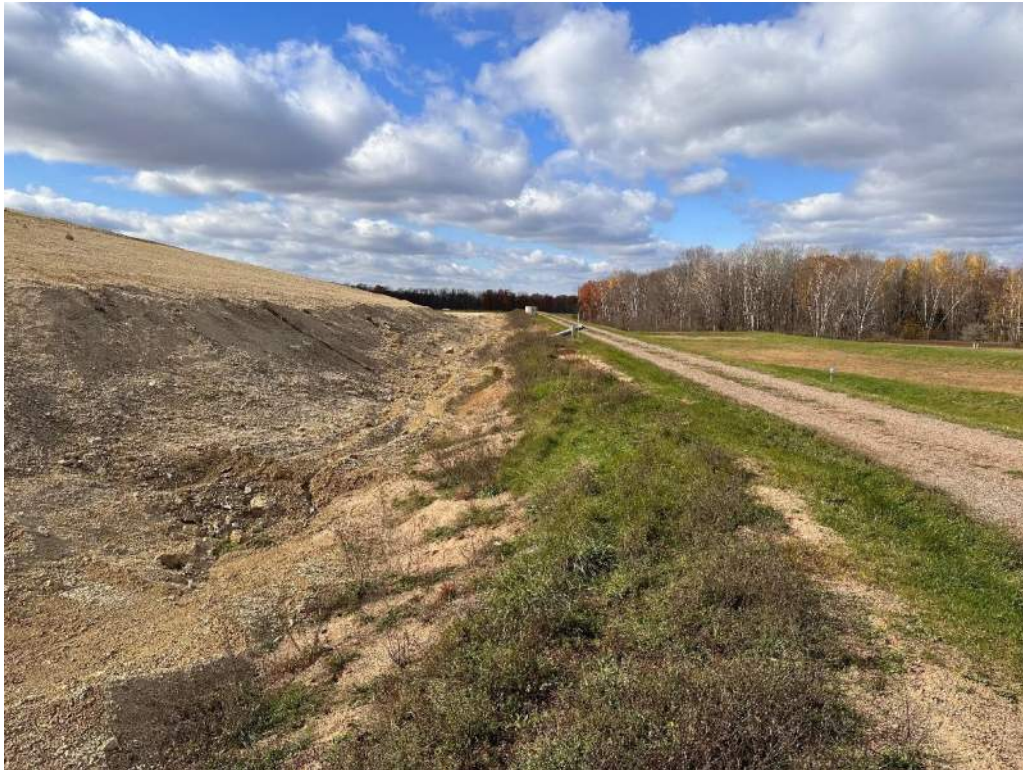
Photo No. 9 – Looking west at the Cell 1 north perimeter slope and leachate collection ditch.

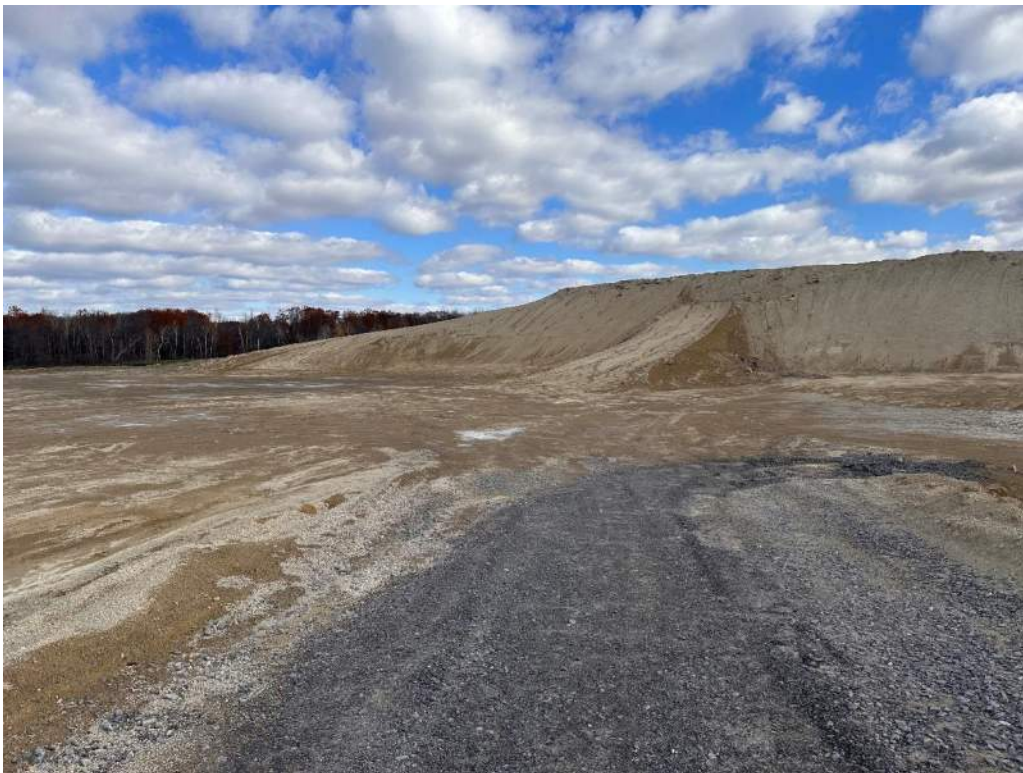
Photo No. 10 – Looking northeast to the Cell 1 active filling area and east slope.

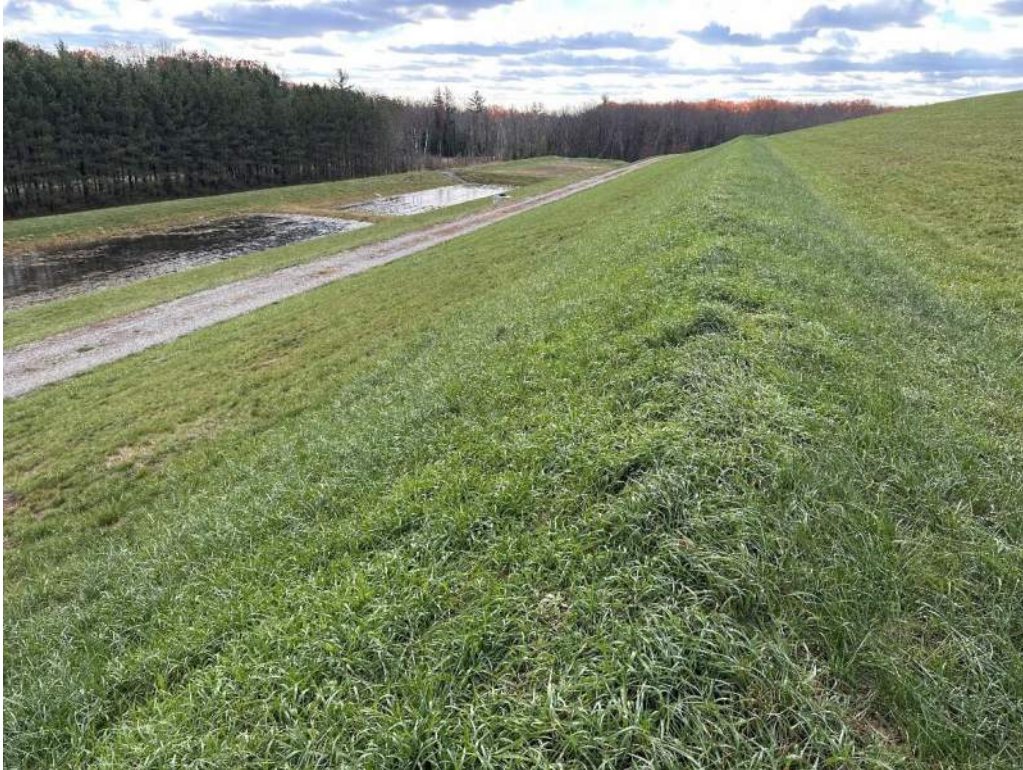
Photo No. 11 – Looking south at the Cell 2 east stormwater control ditch.

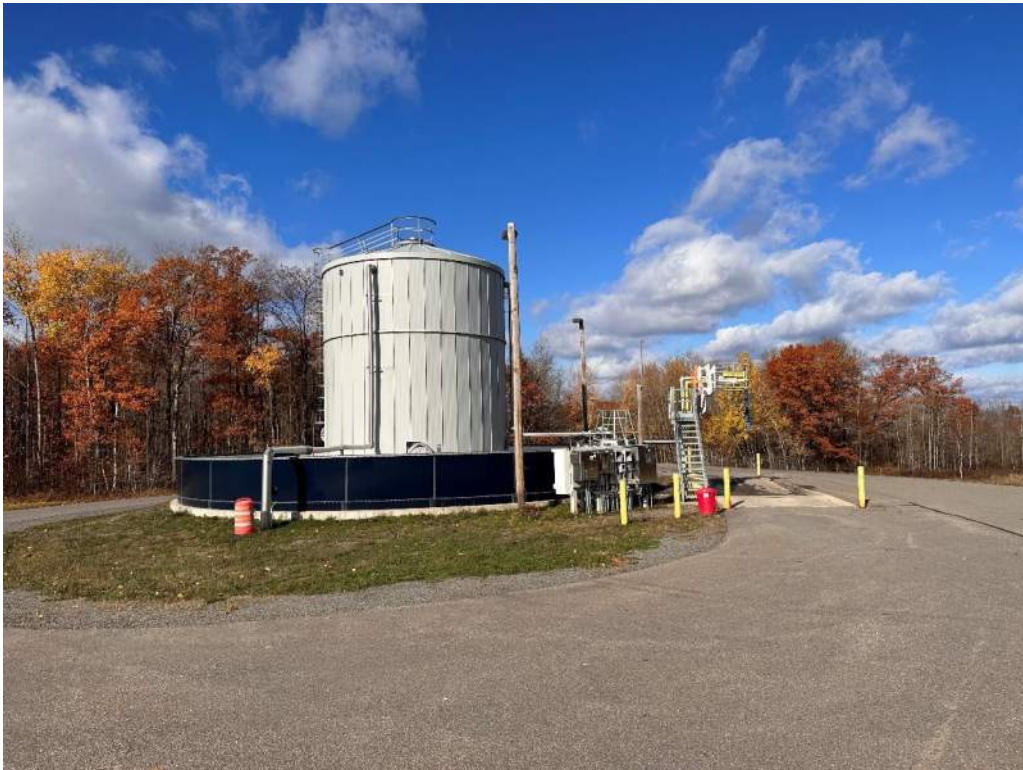
Photo No. 12 – Leachate collection tank and loadout facility.

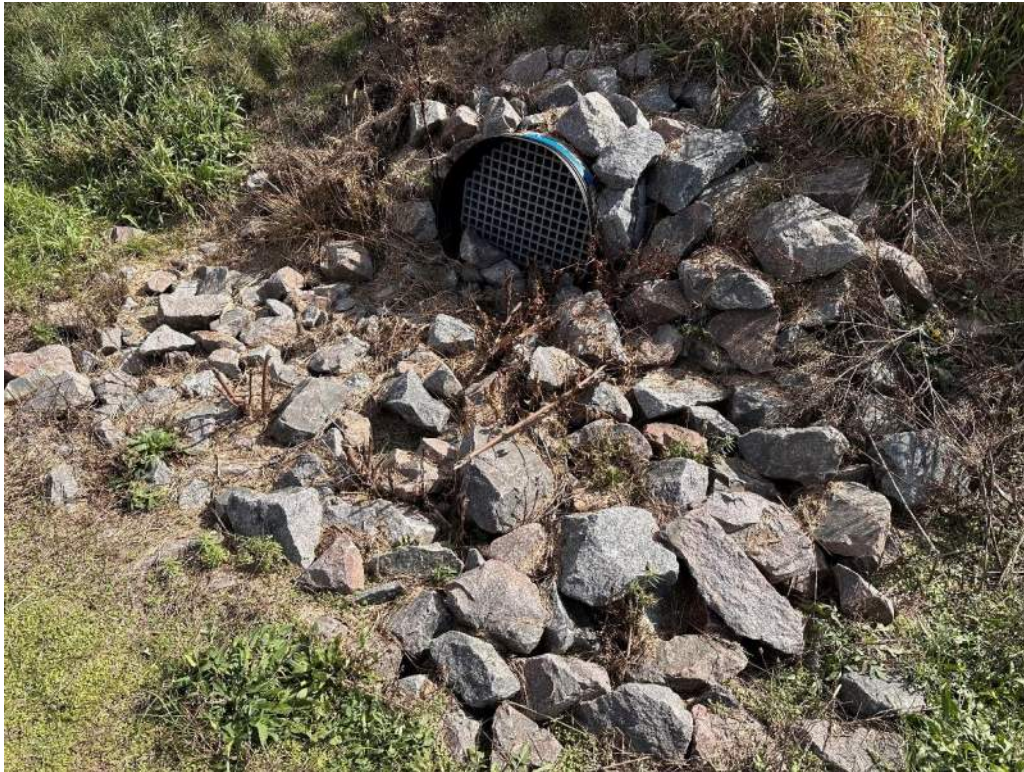
Photo No. 13 – Stormwater diversion berm inlet on the southeast corner of Cell 2.

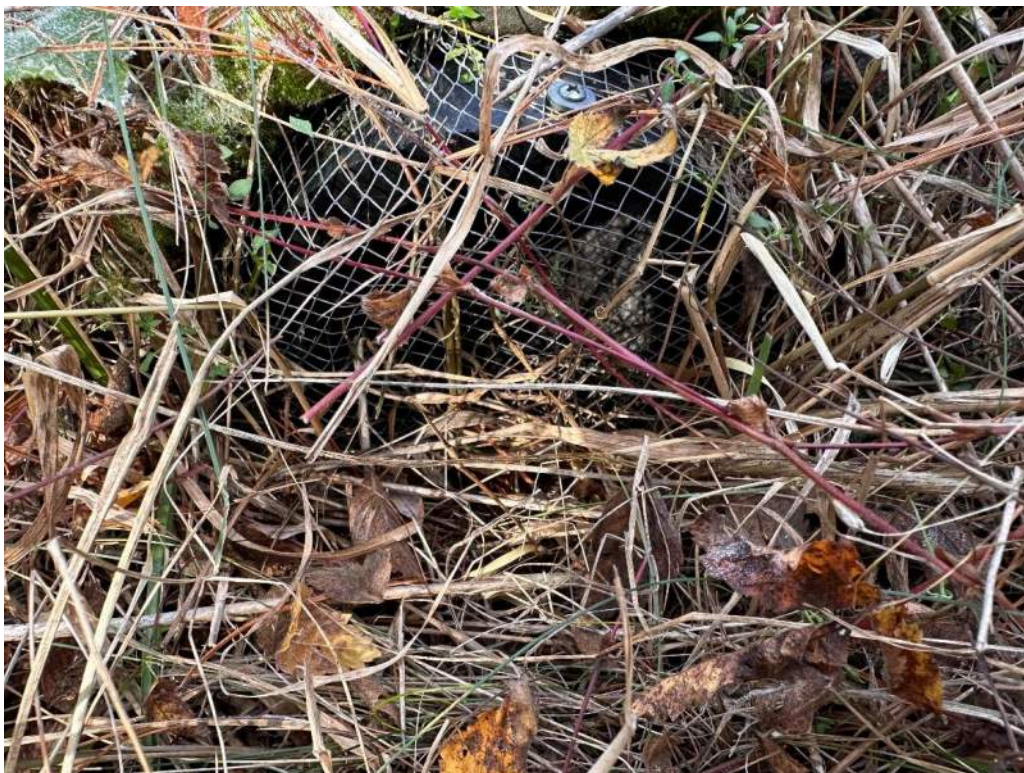
Photo No. 14 – Cell 2 gradient control outlet pipe.

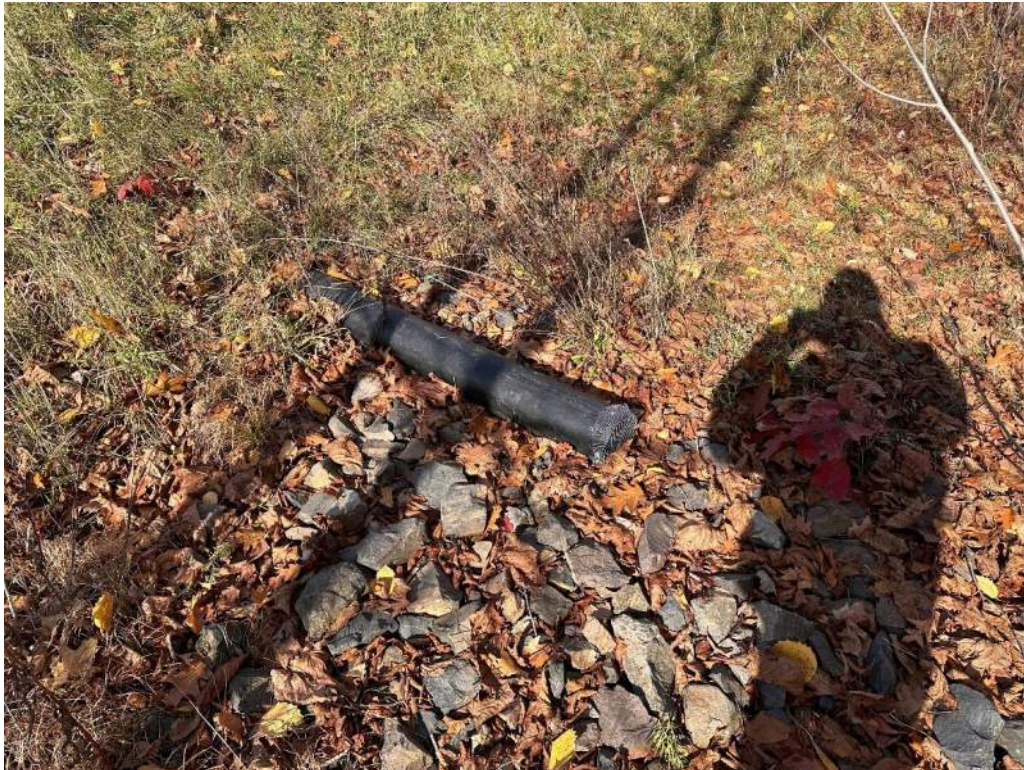
Photo No. 15 – Cell 1 gradient control outlet pipe.

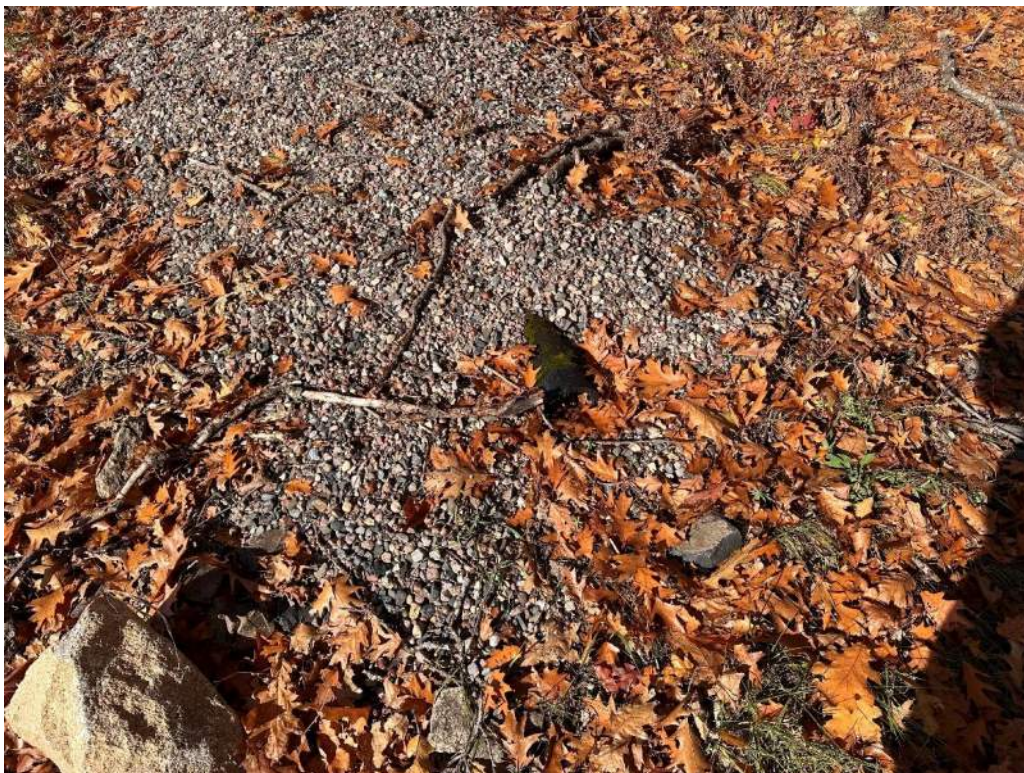
Photo No. 16 – Cell 1 gradient control outlet pipe.
