December 19, 2024
Project No. 2103691

**Re: 2024 Landfill Inspection Report
Weston Disposal Site No. 3
Wisconsin Public Service Corporation
Town of Knowlton, Marathon County, Wisconsin**

2024 Landfill Inspection Report
Weston Disposal Site No. 3
Wisconsin Public Service Corporation
Town of Knowlton, Marathon County, Wisconsin
December 19, 2024

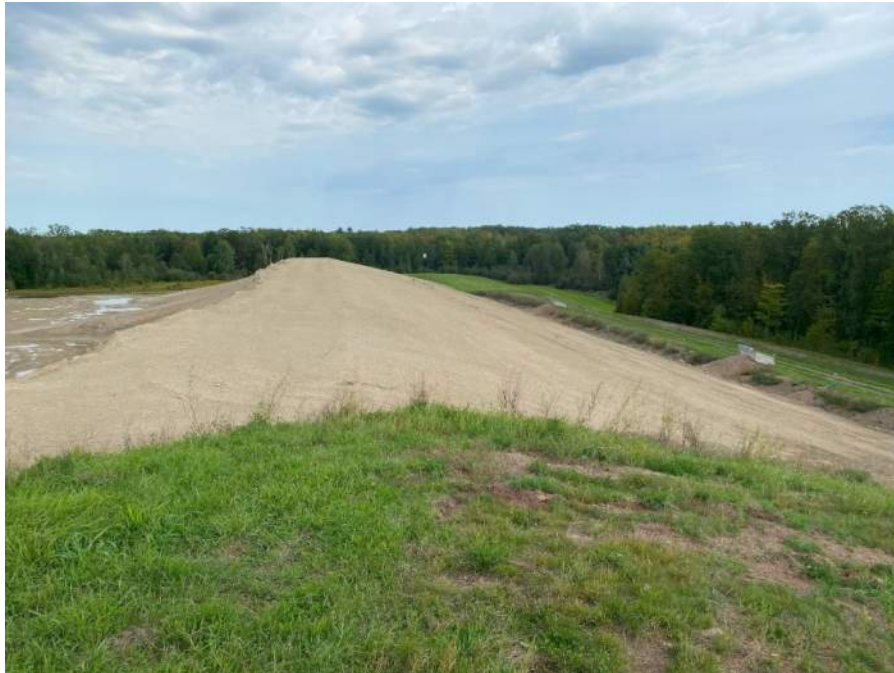
Photo No. 1 – Active filling area on Cell 1 and Cell 2, looking north.

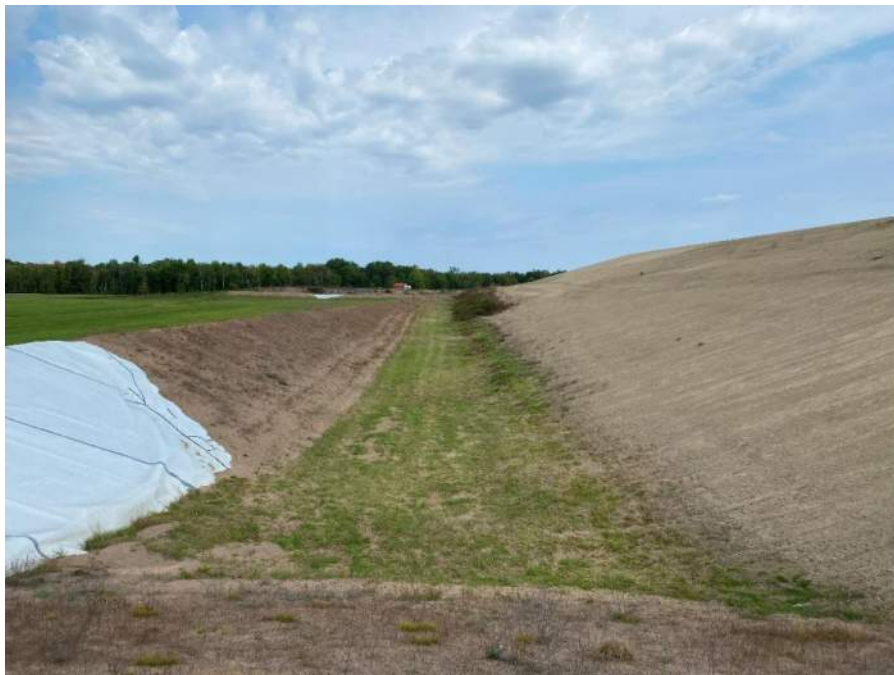
Photo No. 2 – Cell 2/3 intercell berm and leachate collection ditch along west side of Cell 2.

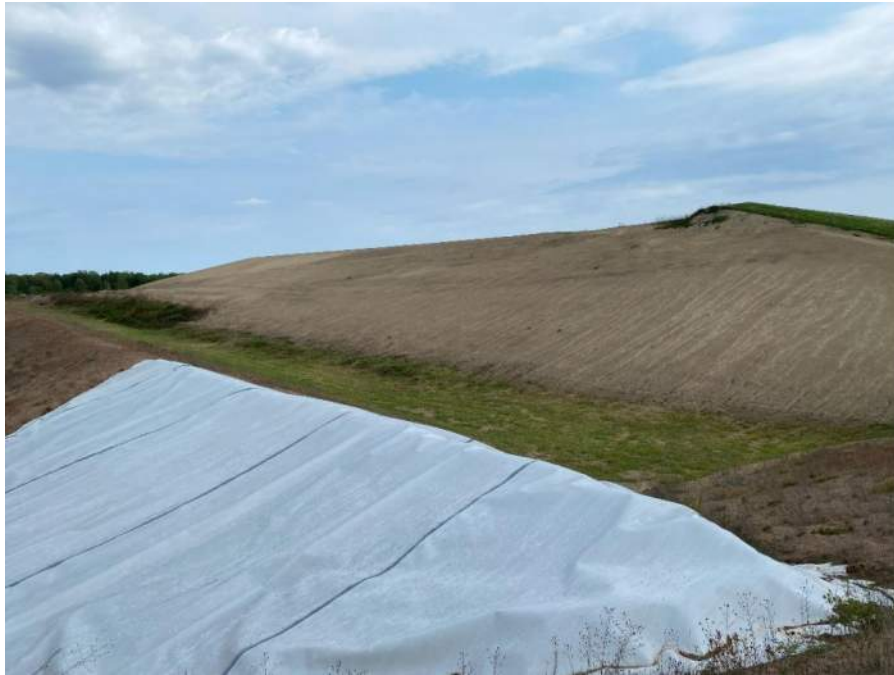
Photo No. 3 – Cell 2 west slope.

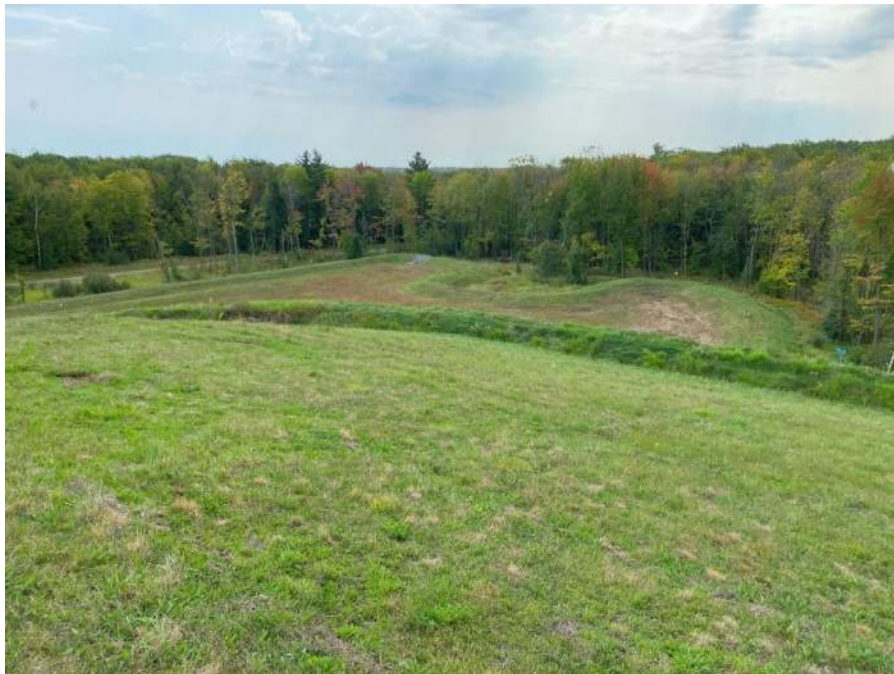
Photo No. 4 – Cell 2 south slope and stormwater diversion berm.

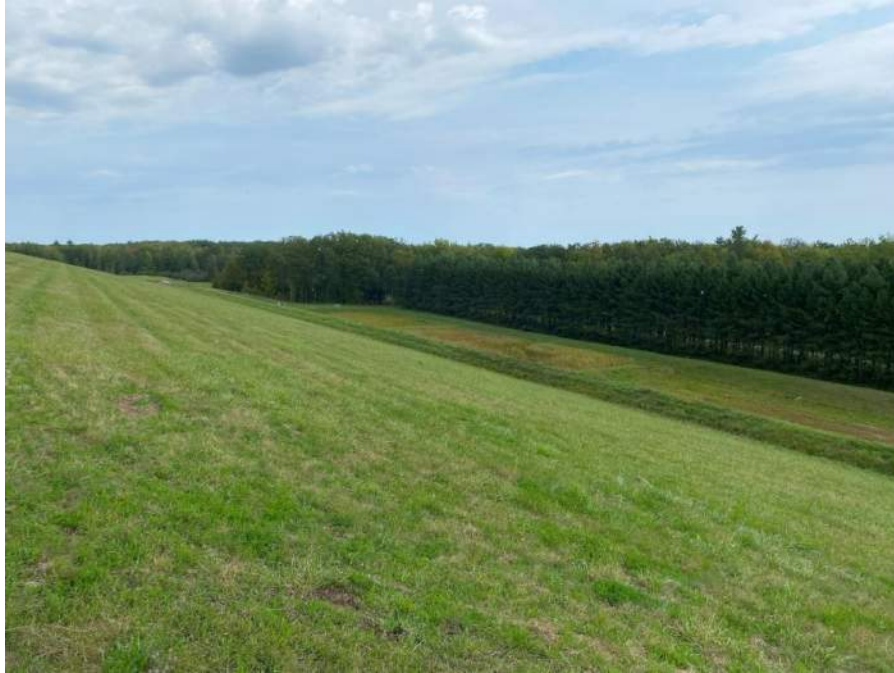
Photo No. 5 – Stormwater Basin 2 east of Cell 2.

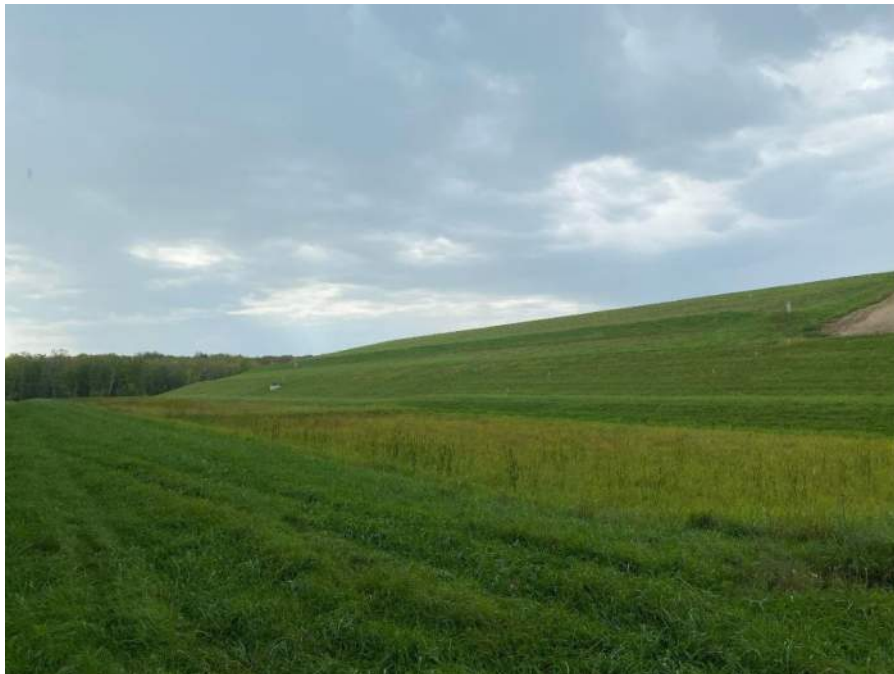
Photo No. 6 – Stormwater Basin 2 and Cell 2 final cover.

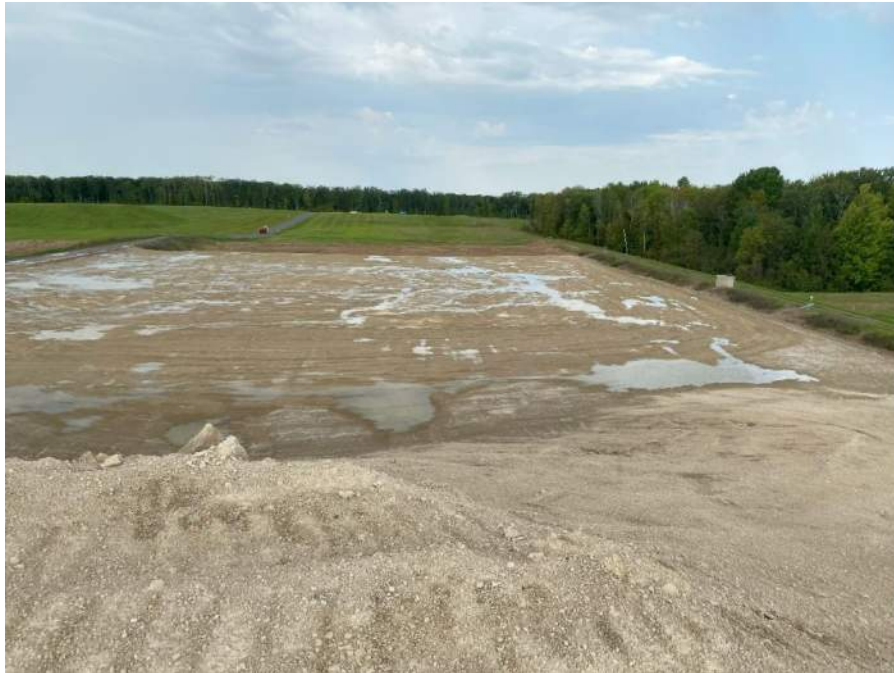
Photo No. 7 – Active filling area in Cell 1, looking west. Active area watered for dust control.

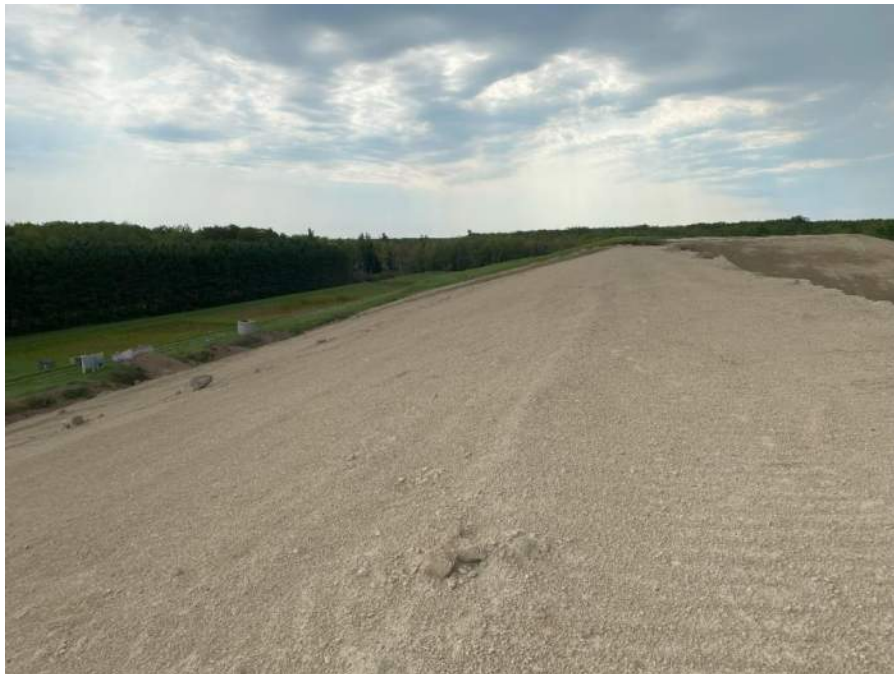
Photo No. 8 – Looking south on the Cell 1 active filling area and the east slope prepared for final cover.

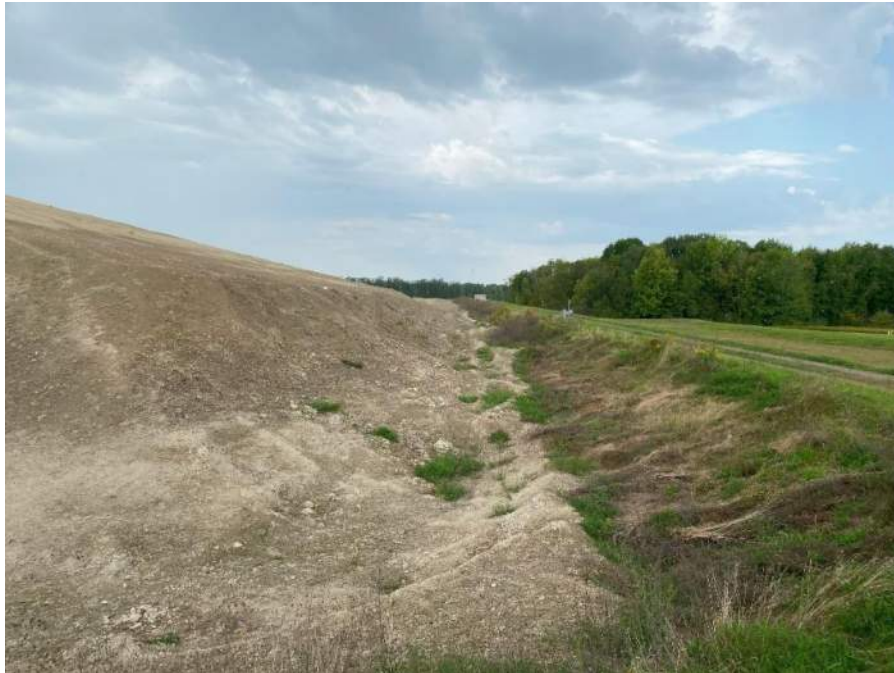
Photo No. 9 – Looking west at the Cell 1 north perimeter slope and leachate collection ditch.

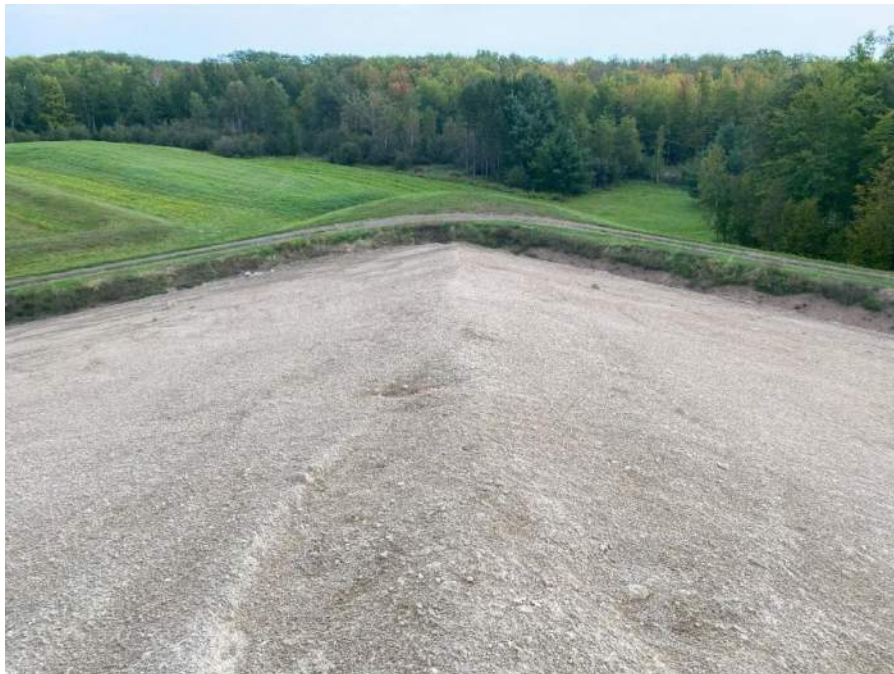
Photo No. 10 – Cell 1 north and east perimeter slopes, looking northeast.

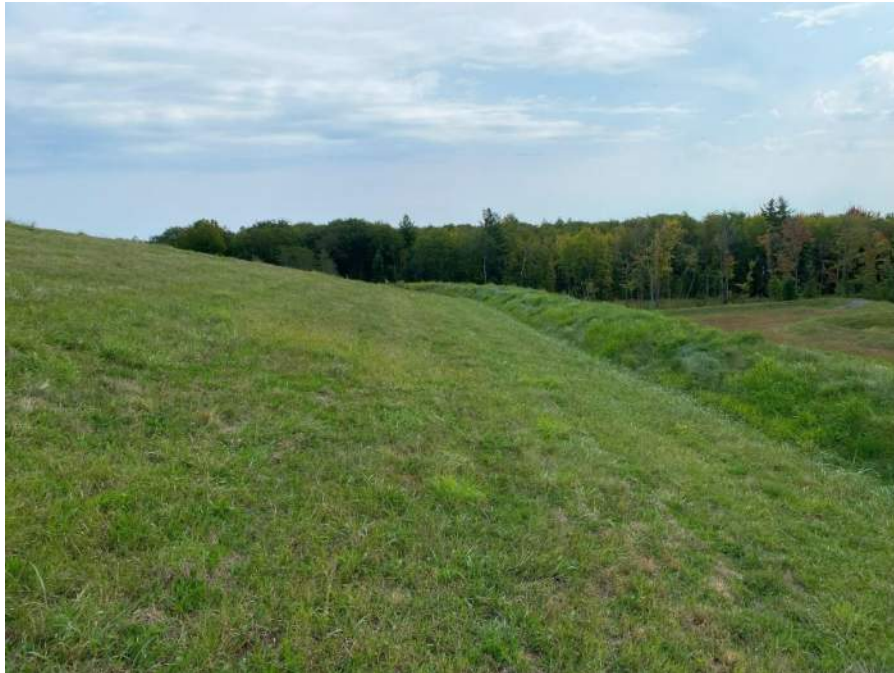
Photo No. 11 – Looking east at the Cell 2 east stormwater control ditch.

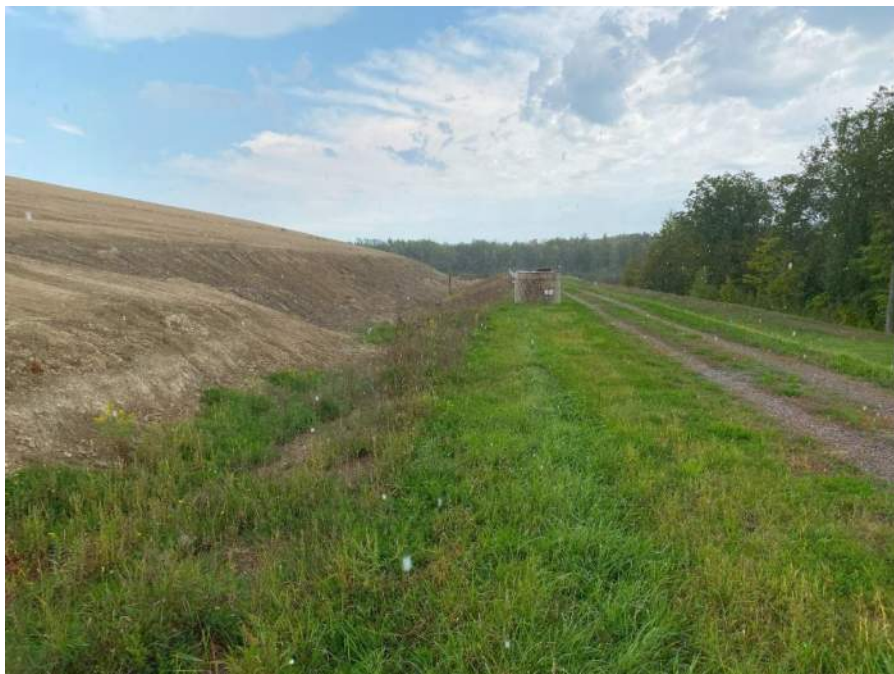
Photo No. 12 – Looking north at the Cell 1 and Cell 2 east perimeter slope and leachate collection ditch.

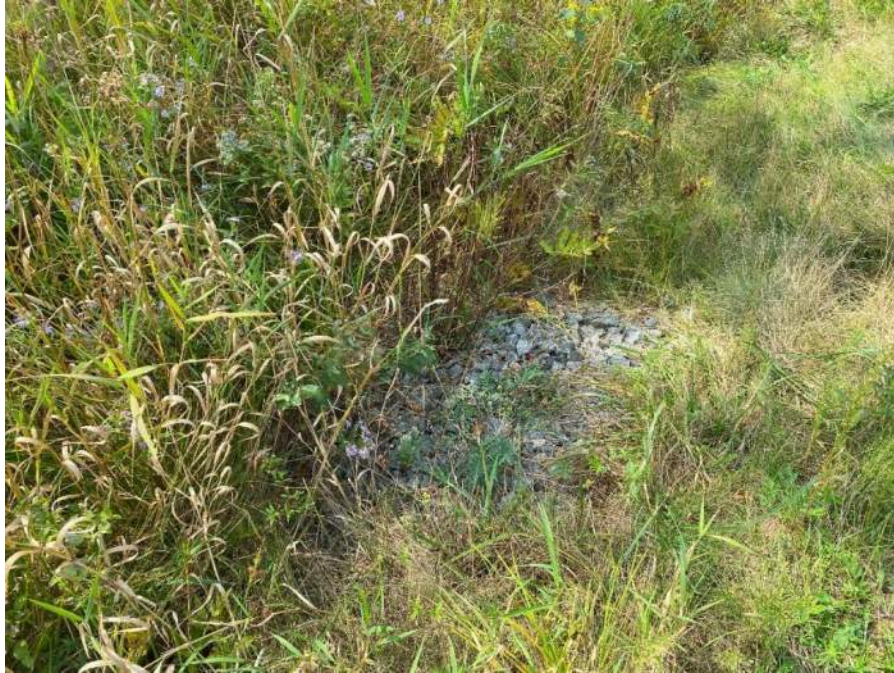
Photo No. 13 – Cell 2 gradient control outlet pipe.

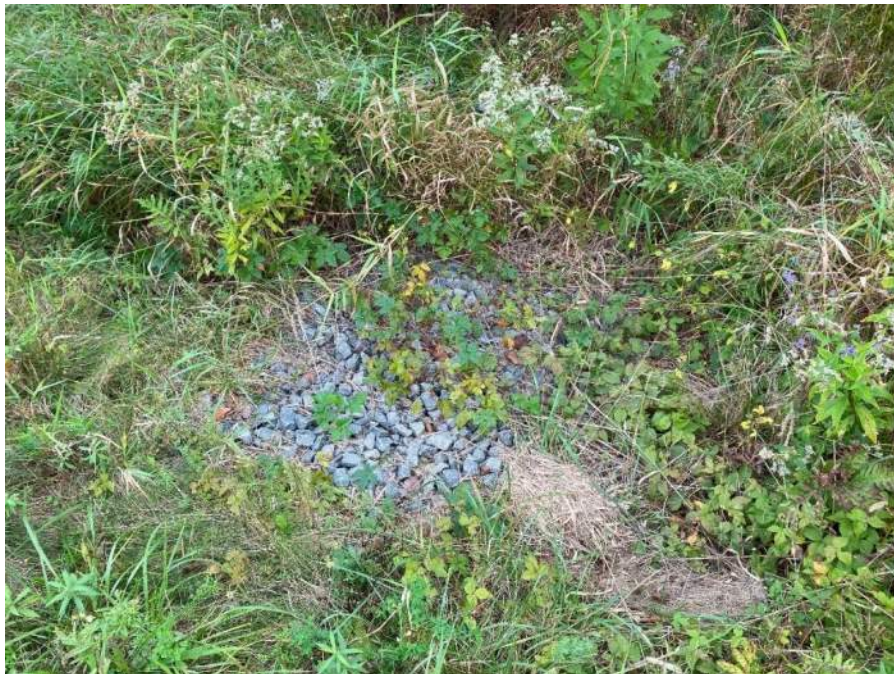
Photo No. 14 – Cell 2 gradient control outlet pipe.

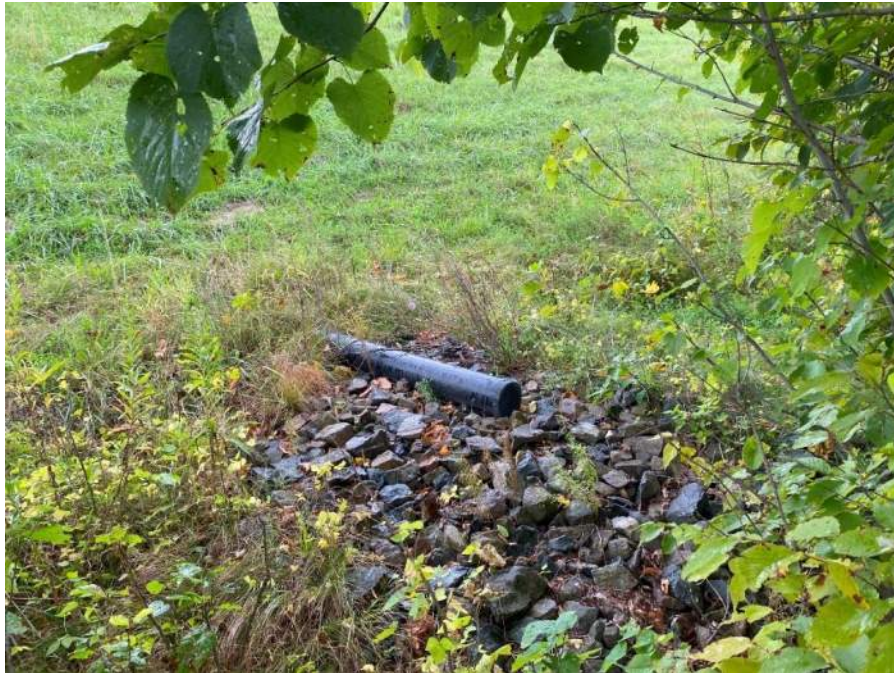
Photo No. 15 – Cell 1 gradient control outlet pipe.

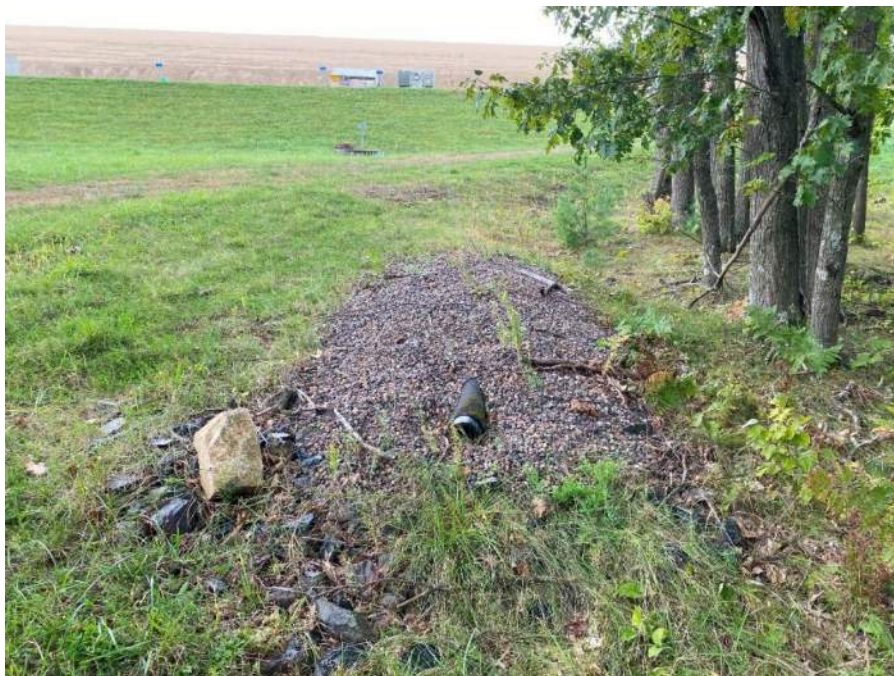
Photo No. 16 – Cell 1 gradient control outlet pipe.
