Document type
CCR Rule Annual Report

Date
January 31, 2020

2019 ANNUAL GROUNDWATER MONITORING AND CORRECTIVE ACTION REPORT

WESTON DISPOSAL SITE NO. 3 LANDFILL

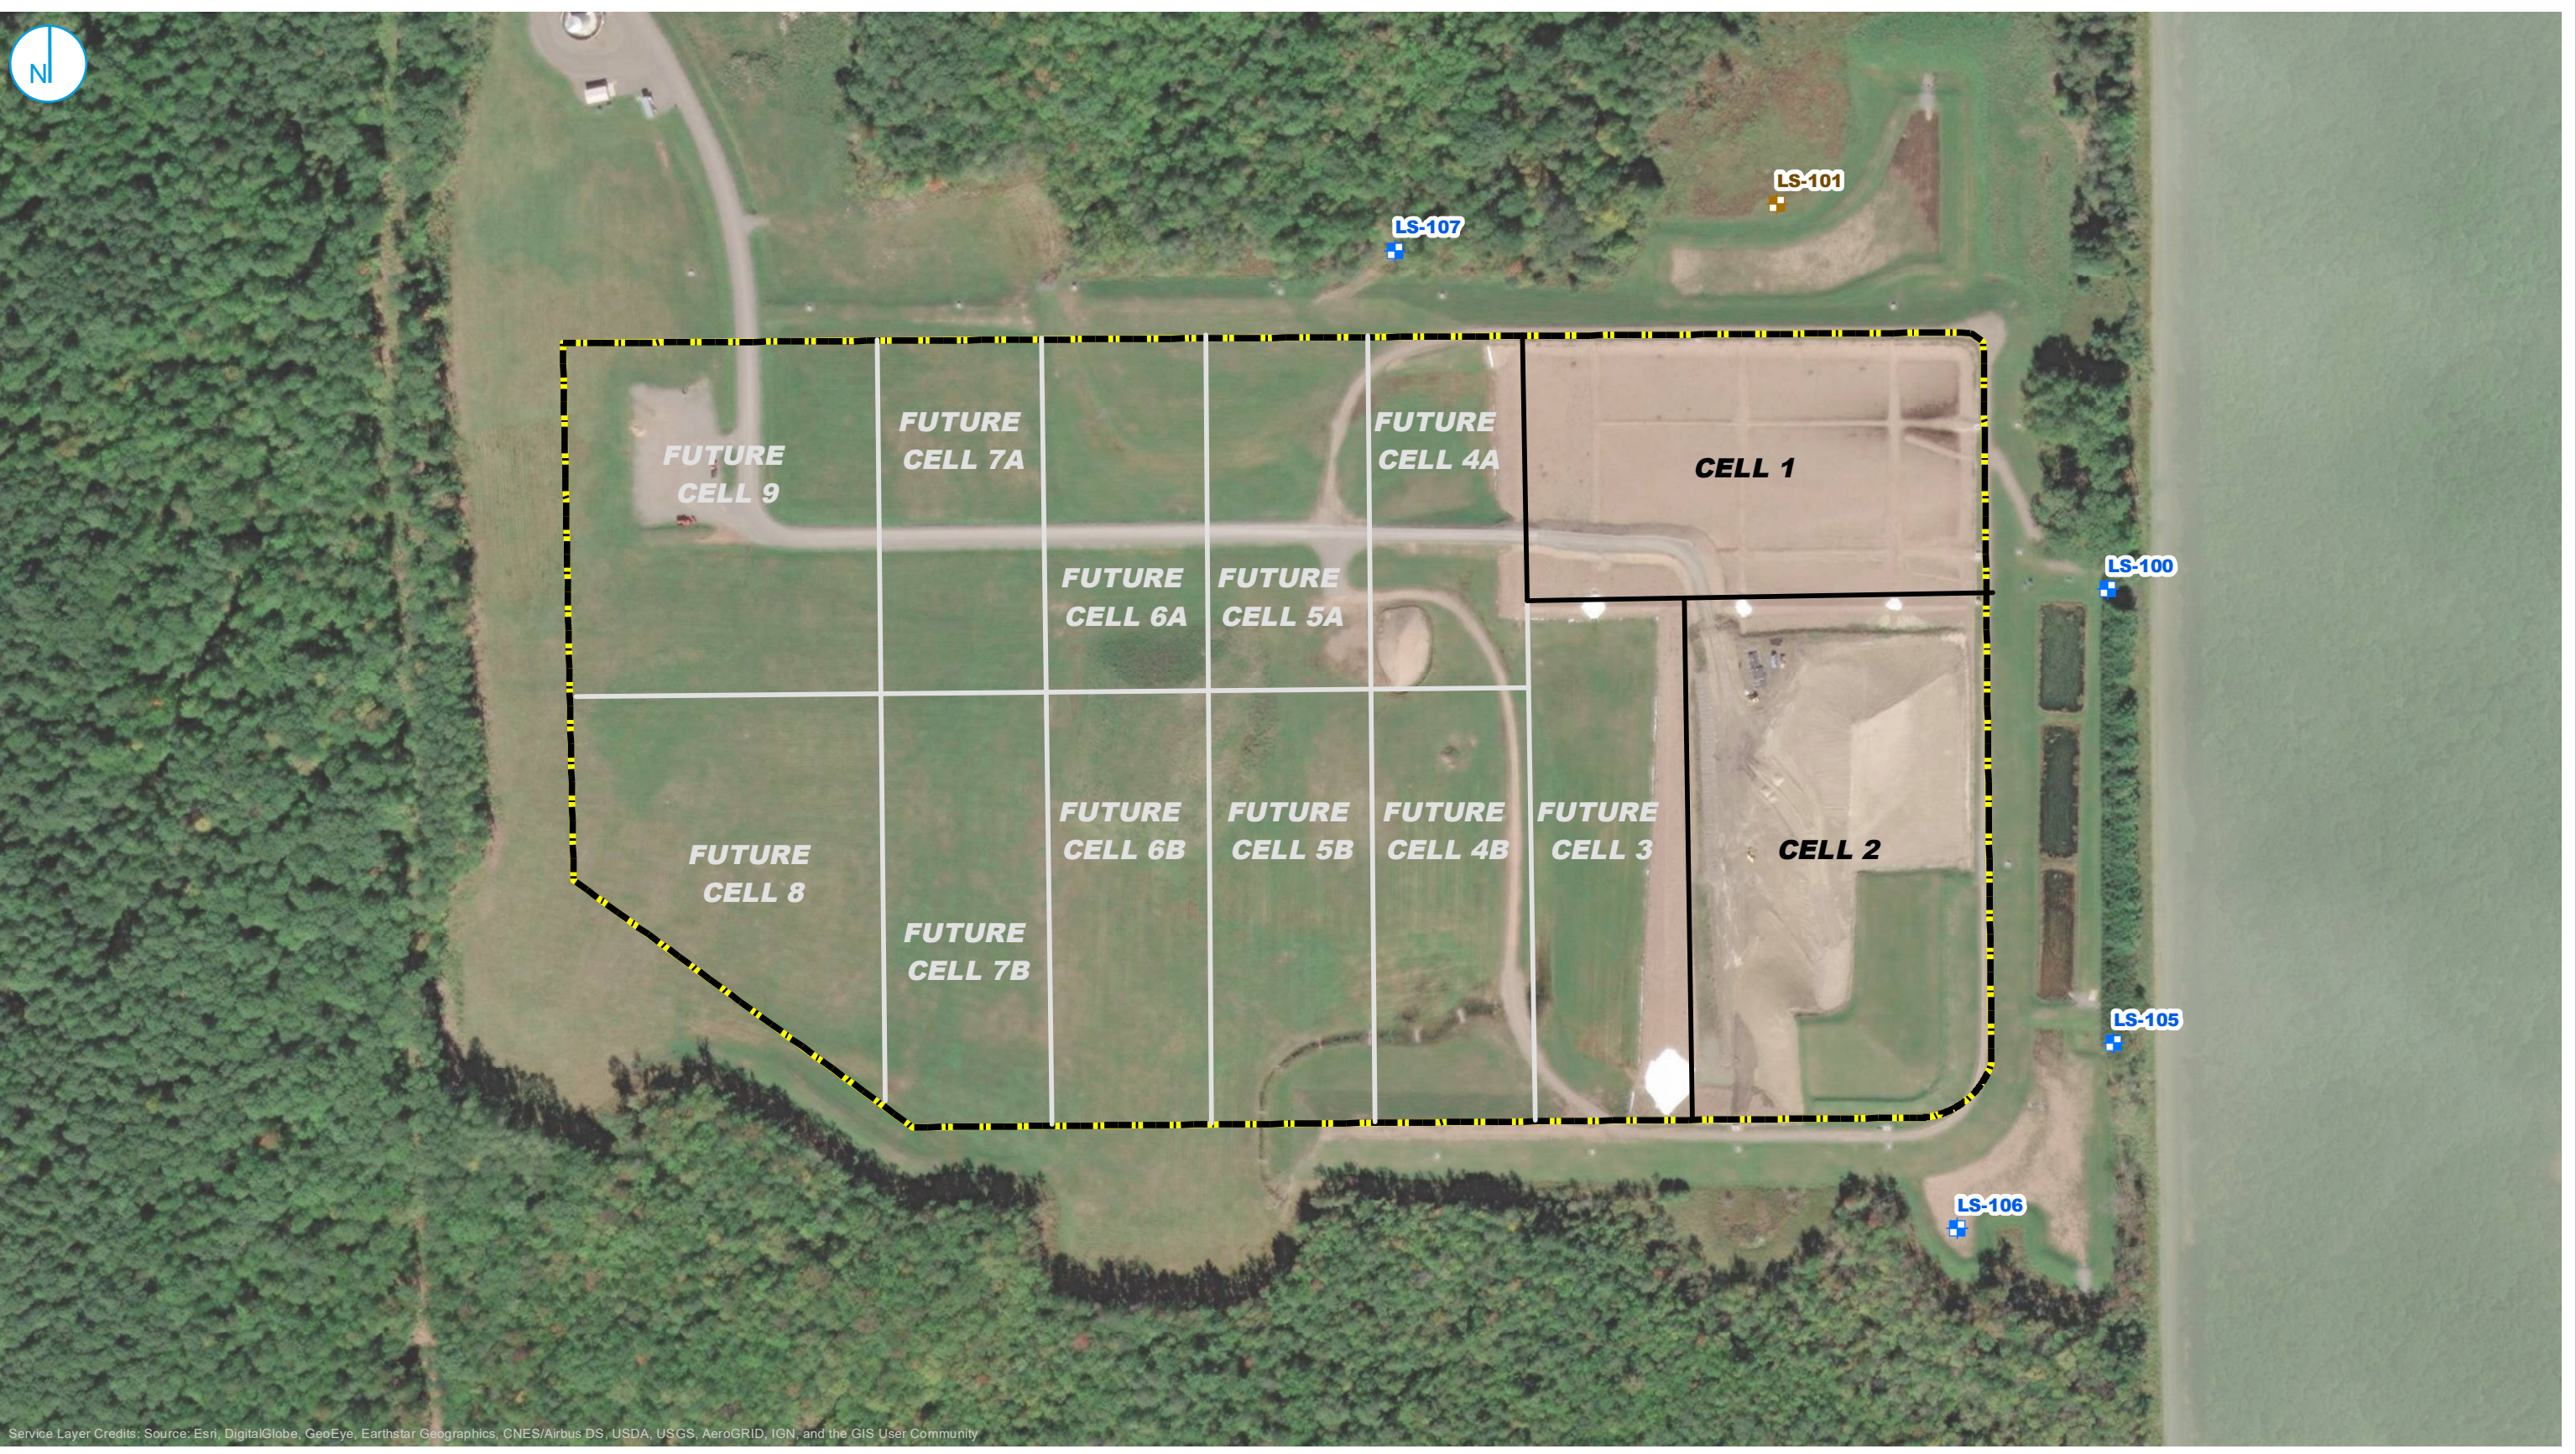
FIGURE 1

GROUNDWATER SAMPLING WELL LOCATION MAP

A map showing the groundwater monitoring system, including the CCR unit and all background (upgradient) and downgradient monitoring wells with well identification numbers, for WDS3 Landfill No. 3 is presented on Figure 1. There were no changes to the monitoring system in 2019.

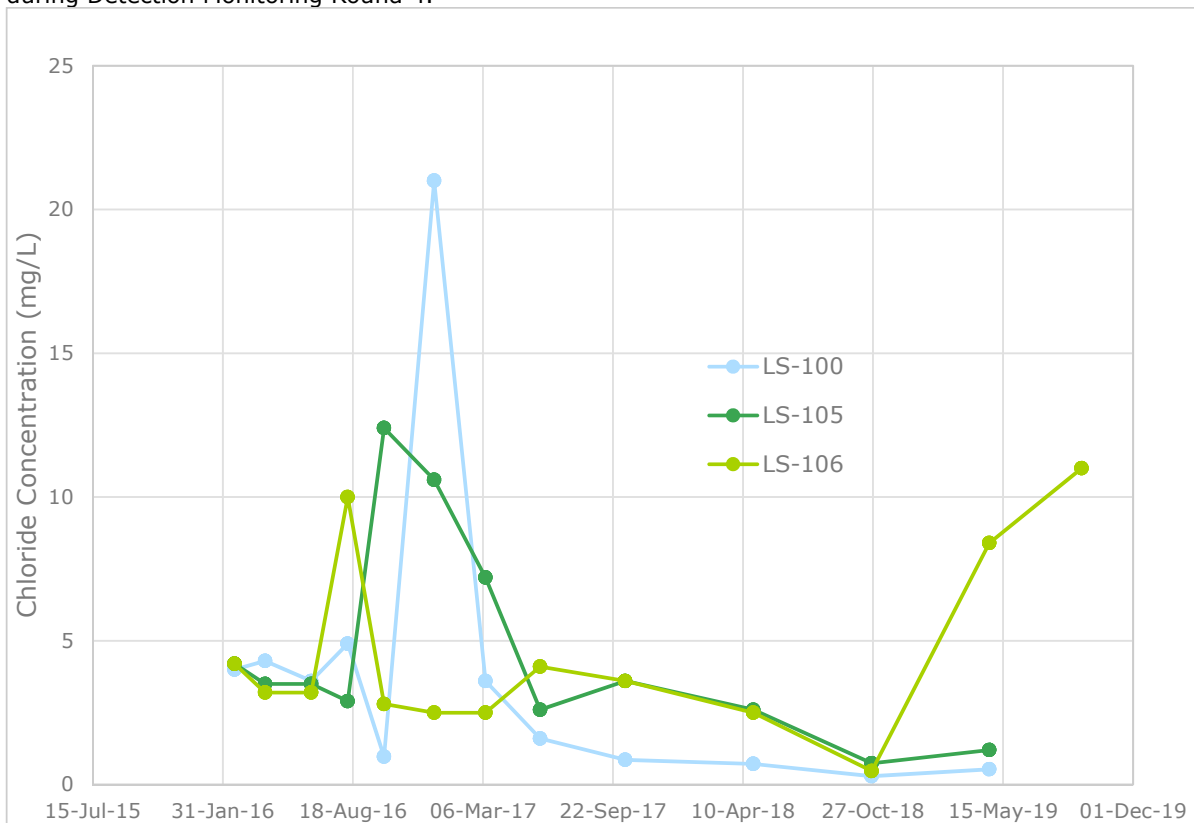
Figure 2. Time Series Plot of Chloride at LS-100, LS-105, and LS-106

The concentration of chloride in LS-100 and LS-105 during 2016 sampling were detected at similar concentrations to those detected in LS-106 during April and September 2019. The groundwater flow direction is influenced by the groundwater gradient control system and both of these wells are upgradient of LS-106. Figure 2 (below) illustrates the concentrations of chloride in LS-100, LS-105, and LS-106. The concentrations of chloride in 2016 are approximately equal, or greater than those detected during Detection Monitoring Round 4.

LS-100 and LS-105 are located adjacent to Legner Road, where application of deicing materials is a probable source of chloride. LS-106 is located downgradient of these locations and downstream of surface water runoff from these areas. These data show that there is variability in the chloride concentration upgradient and suggest that sources other than the CCR unit are influencing the elevated chloride detected in LS-106.

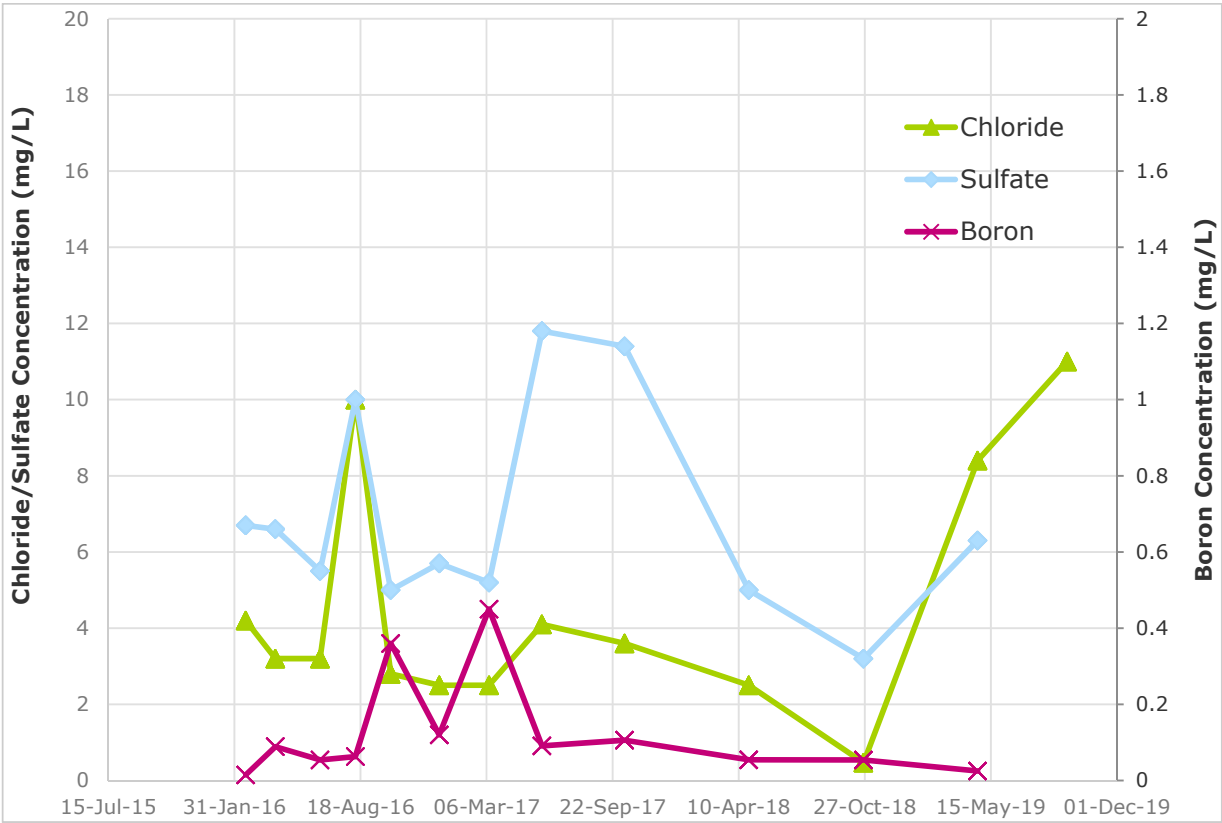
Figure 3. Time Series Plot of Boron, Chloride and Sulfate in LS-106

The concentrations of chloride and other CCR indicators (boron and sulfate) do not show a strong correlation in LS-106 (Figure 2 and 3). It is expected that concentrations would increase for both boron and sulfate in conjunction with chloride if a release had occurred from the CCR unit and resulted in an SSI. Review of the data indicates the following:

- The concentration of boron is not elevated when compared to previous sampling events. Boron is a conservative and non-reactive tracer that is used to identify groundwater potentially impacted by CCR leachate; concentrations of boron are decreasing in LS-106 during the last 5 monitoring events. The lack of elevated boron concentrations in LS-106 concurrent with the chloride detections indicates that impacts from the CCR unit are unlikely.

- The sulfate concentrations display similar variability through time with chloride concentrations although the chloride concentration is generally less variable than the sulfate concentration. During Detection Monitoring Round 4, the chloride concentration increased significantly compared to sulfate concentrations which potentially indicates a different source.

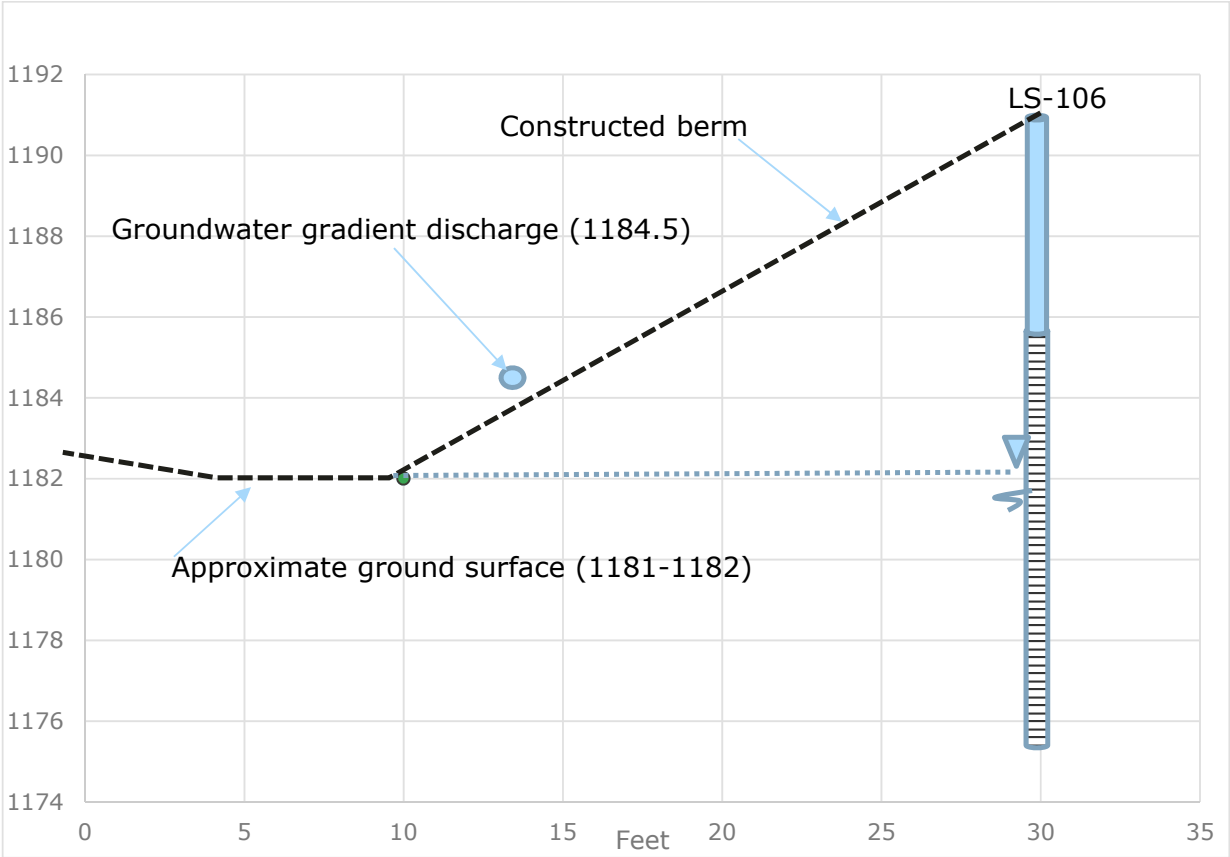
Figure 4. Cross-section of LS-106 and Land Surface

- **Potential Surface Water Infiltration near LS-106:** LS-106 is located in a topographically low area of the site which receives surface water runoff from much of the surrounding area. The construction of the well in a bermed area results in little separation between potential surface water ponding and infiltration and the well screen.

The topography of WDS3 results in surface water flow to the south near LS-106, where it sometimes pools and infiltrates depending on magnitude of precipitation. The groundwater gradient control system also discharges to the area around LS-106. LS-106 is installed through a constructed berm and because of the elevation change is screened across what is the land surface a short distance (15-20 feet) from where surface water and groundwater accumulates. There is potential for surface water runoff, including water in contact with deicing materials along Legner Road, to affect the groundwater in LS-106 because it is screened at an elevation that is across the nearby land surface. If variability in groundwater quality continues and is considered attributable to the location and construction of the well, the need for a replacement well may be evaluated but due to the topography, geologic conditions, and surrounding wetlands a suitable location downgradient of the landfill may not be feasible. The groundwater elevations measured within LS-106 indicate that the water level is generally near the native land surface (between 1181 and 1183 ft). A general cross-section of the land surface LS-106 is shown in Figure 4 below.

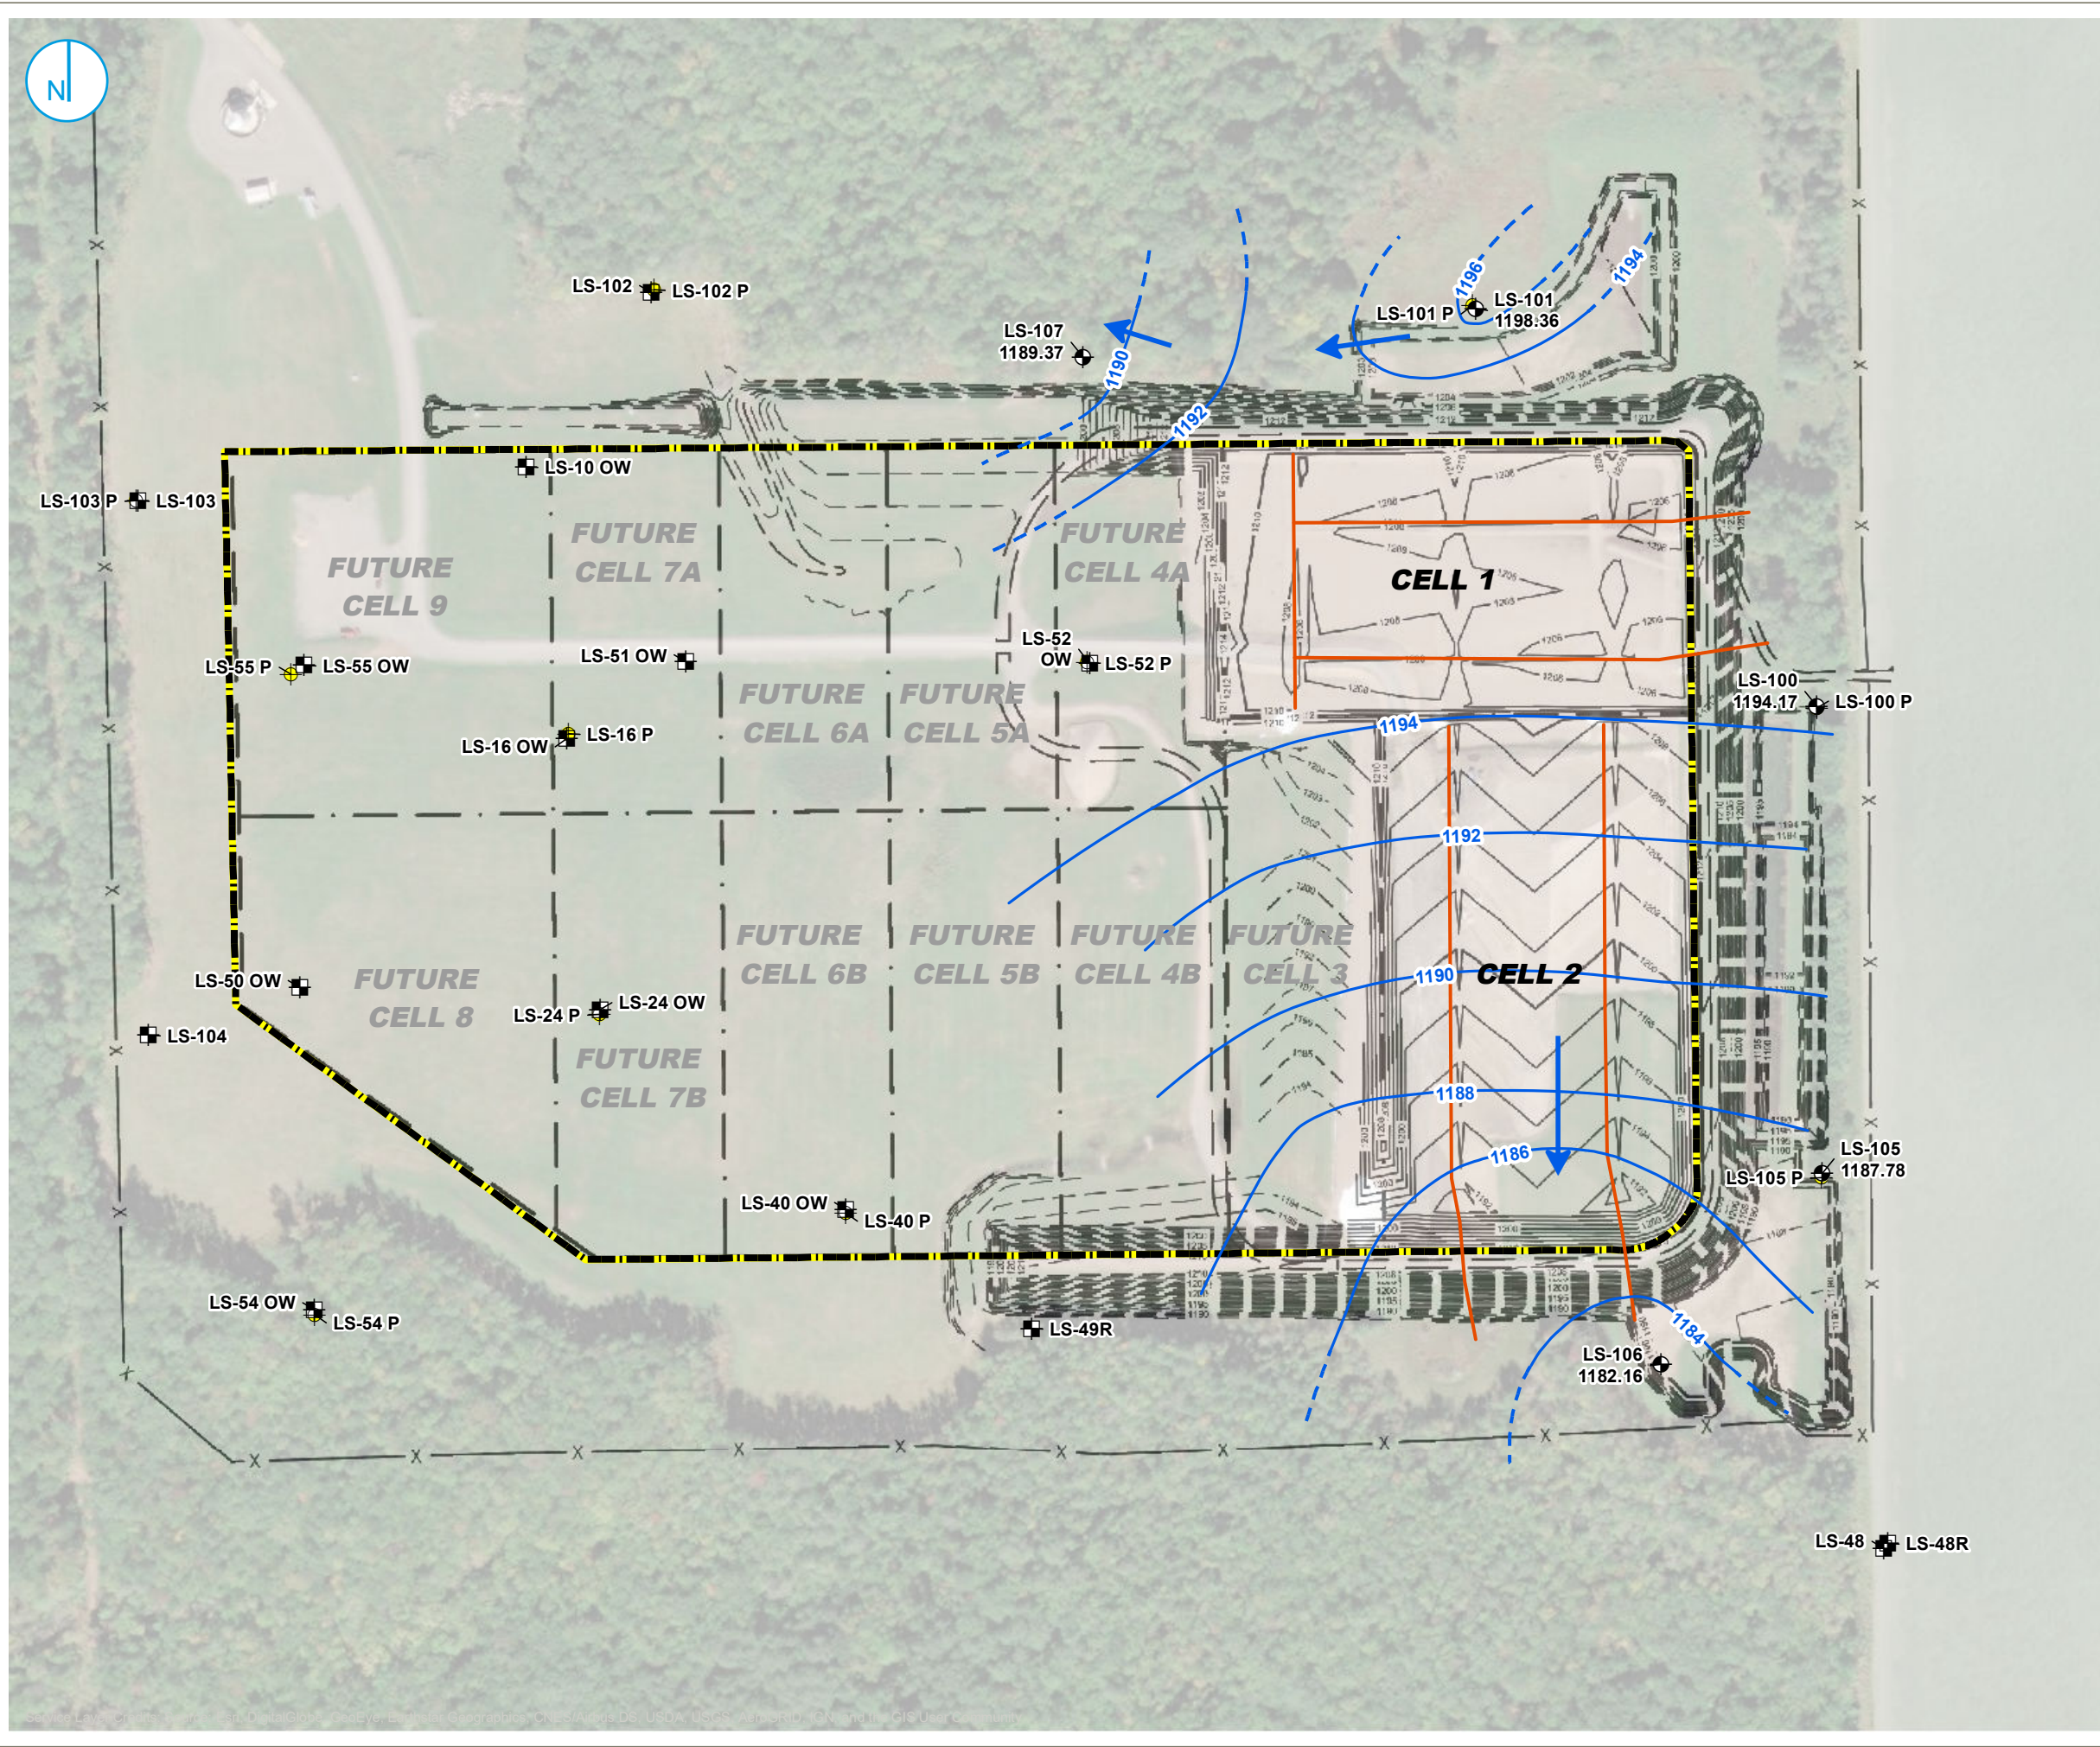
FIGURE 01

**WESTON DISPOSAL SITE NO. 3
UPPERMOST AQUIFER UNIT
GROUNDWATER ELEVATION CONTOUR MAP
DETECTION MONITORING ROUND 4 - APRIL 2019**

This document has been prepared by O'Brien & Gere Engineers, Inc., a Ramboll company (Ramboll) to provide pertinent information for an alternate source demonstration (ASD) as allowed by 40 CFR Section 257.94(e)(2) for the Weston Disposal Site No. 3 (WDS3) Landfill, located in the Town of Knowlton, Wisconsin (Figure 1).
