December 10, 2021  
Project 2103691

**Re: Landfill Inspection Report for the  
Weston Disposal Site No. 3  
Wisconsin Public Service Corporation  
Town of Knowlton, Marathon County, Wisconsin**

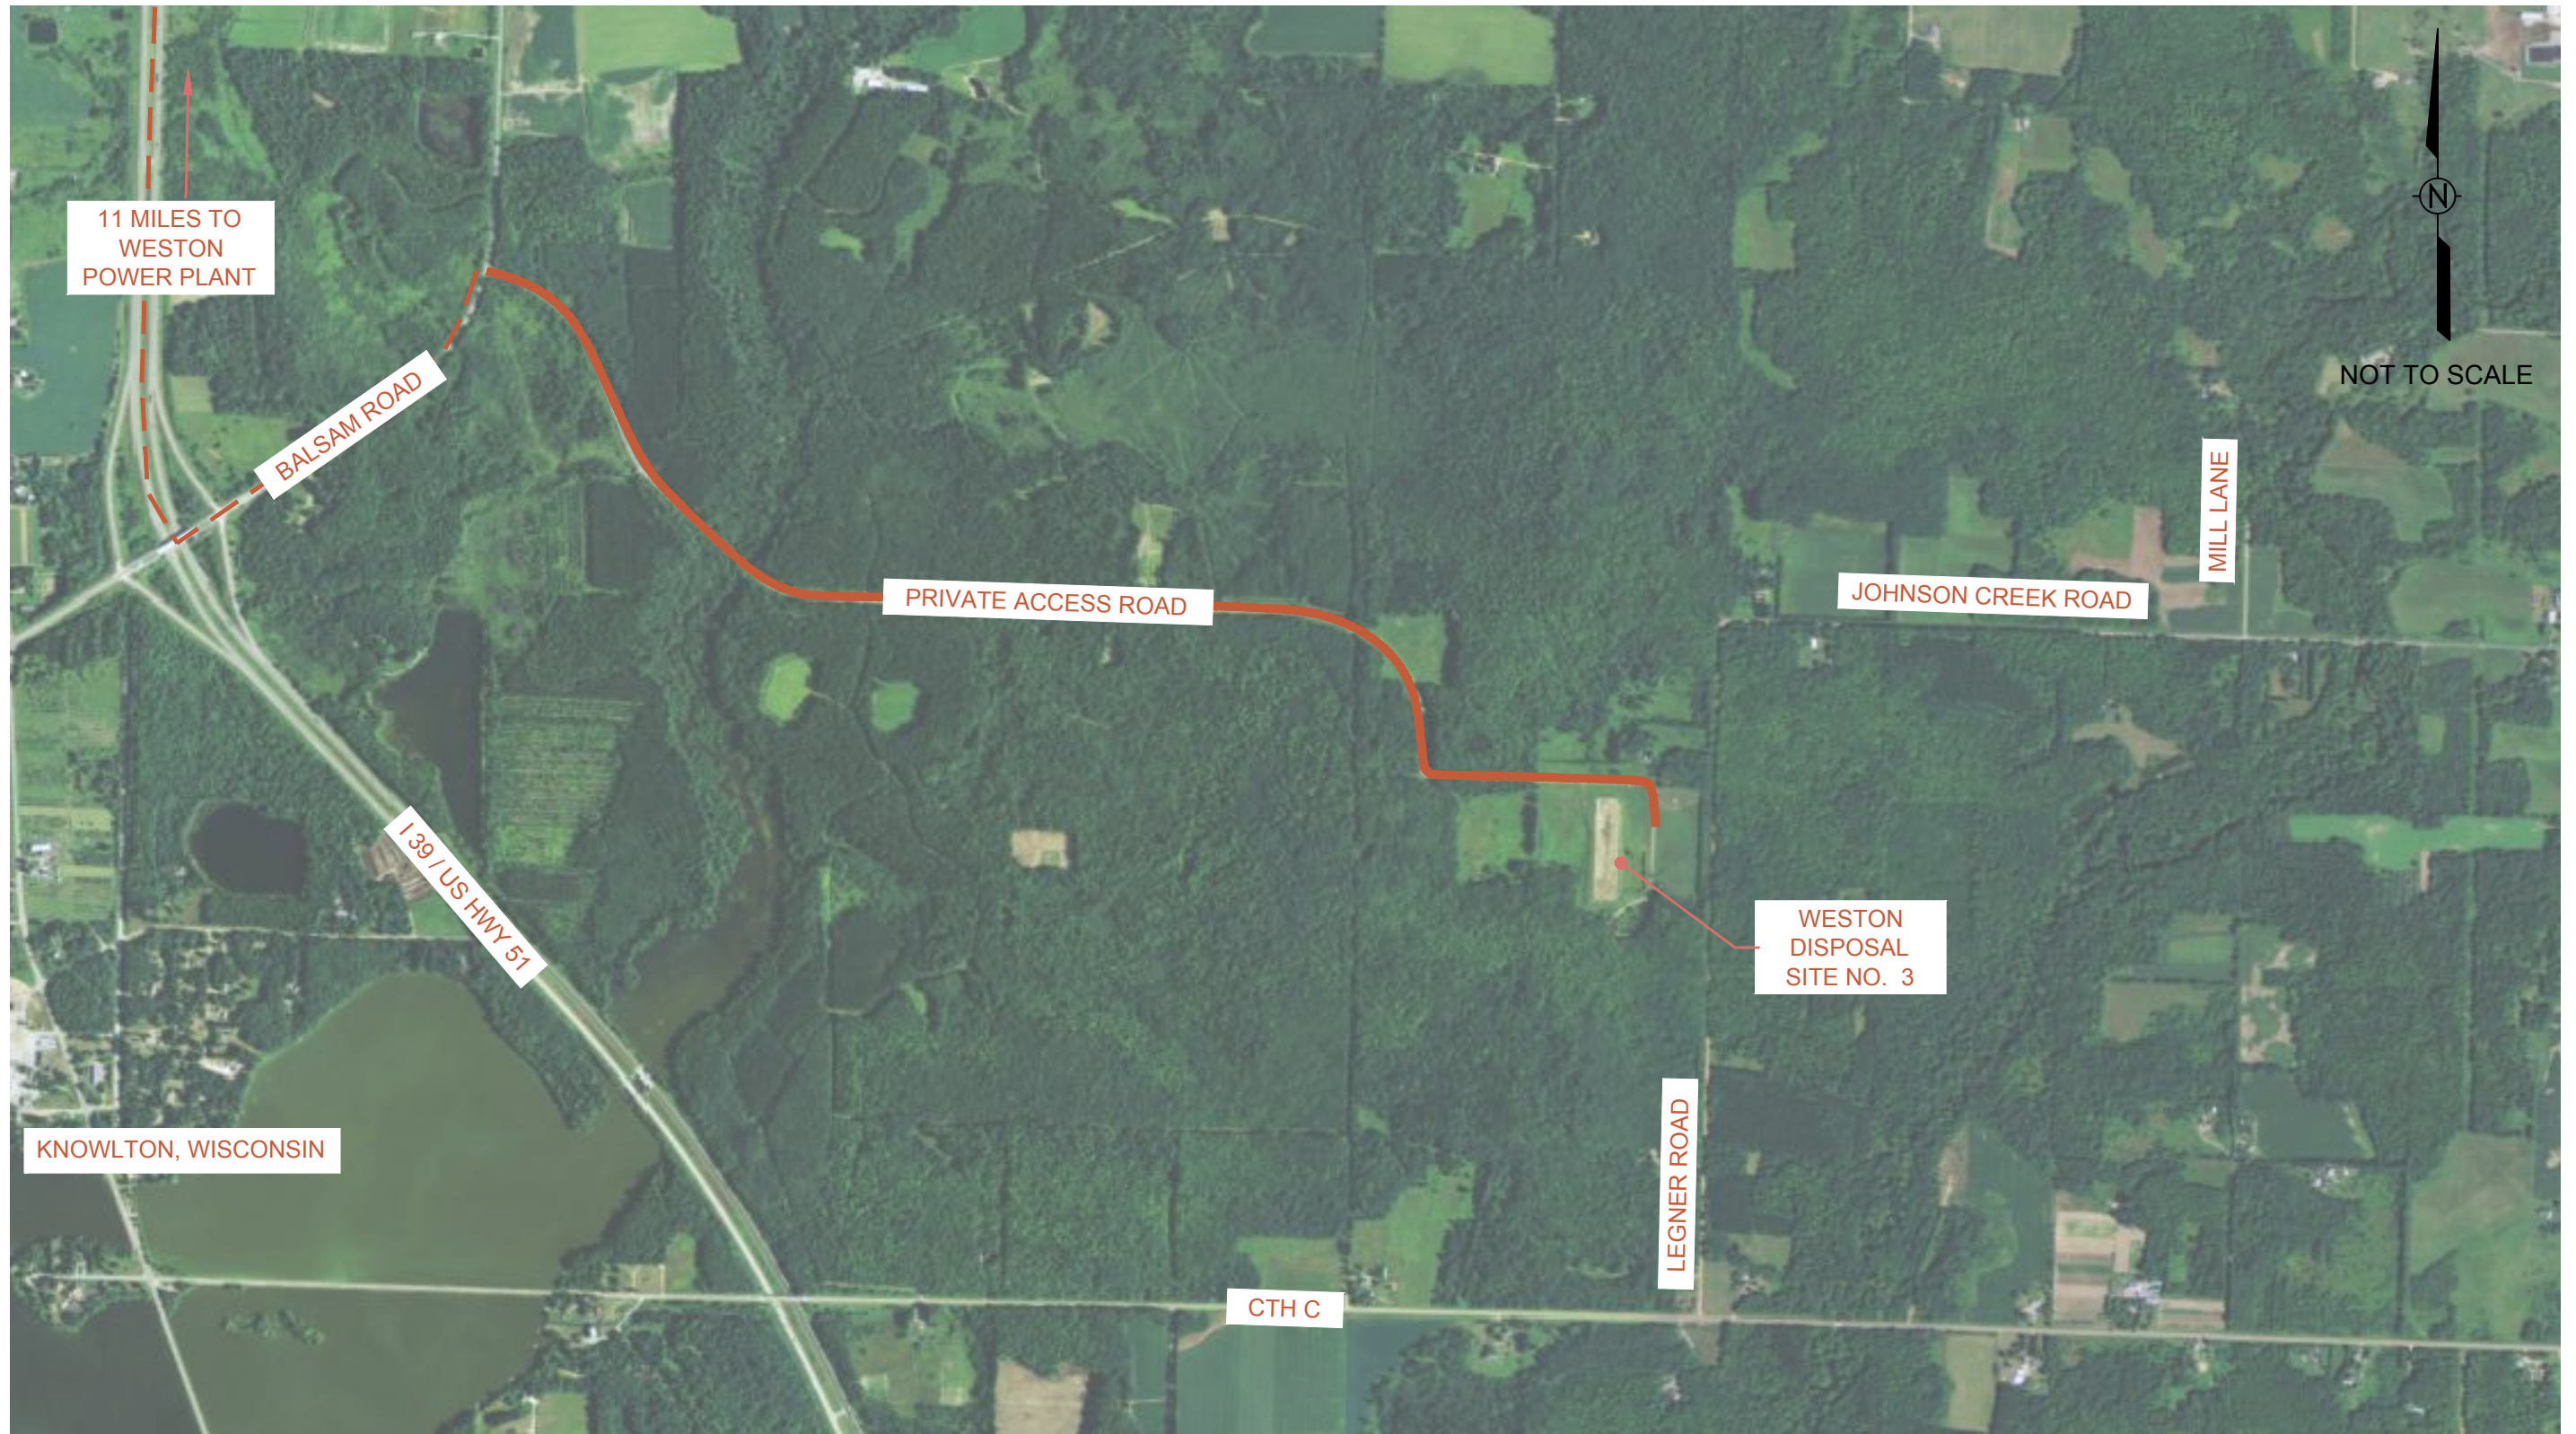
<i>Photo No. 1 – Looking north showing the Cell 2 active filling area.</i>	<u>1</u>
<i>Photo No. 2 - Along cell 2-3 intercell berm.</i>	<u>1</u>
<i>Photo No. 3 – Along south perimeter berm near Leachate Extraction Vault P2B.</i>	<u>2</u>
<i>Photo No. 4 – Looking at the south perimeter slope from the top of the final cover.</i>	<u>2</u>
<i>Photo No. 5 - From top of Cell 2 partial final cover at Stormwater Basin 2 and Stormwater Basin 3.</i>	<u>3</u>
<i>Photo No. 6 - From top of Cell 2 partial final cover at Stormwater Basin 2.</i>	<u>3</u>
<i>Photo No. 7 - Placing and spreading the frost protection layer in August. Vegetation was stripped before placement.</i>	<u>4</u>
<i>Photo No. 8 - Looking north to the Cell 1 active filling area showing frost protection layer</i>	<u>4</u>
<i>Photo No. 9 - Looking east at Cell 1 perimeter slopes showing the frost protection layer.</i>	<u>5</u>
<i>Photo No. 10 - Looking at north ash slope in Cell 2 and frost protection layer in Cell 1.</i>	<u>5</u>
